**SAFETY RECOMMENDATION**

**Subject: accident occurred on Palermo airport to the aircraft Airbus A319 registration marks EI-EDM, on September 24th, 2010.**

**1. Synopsis.**

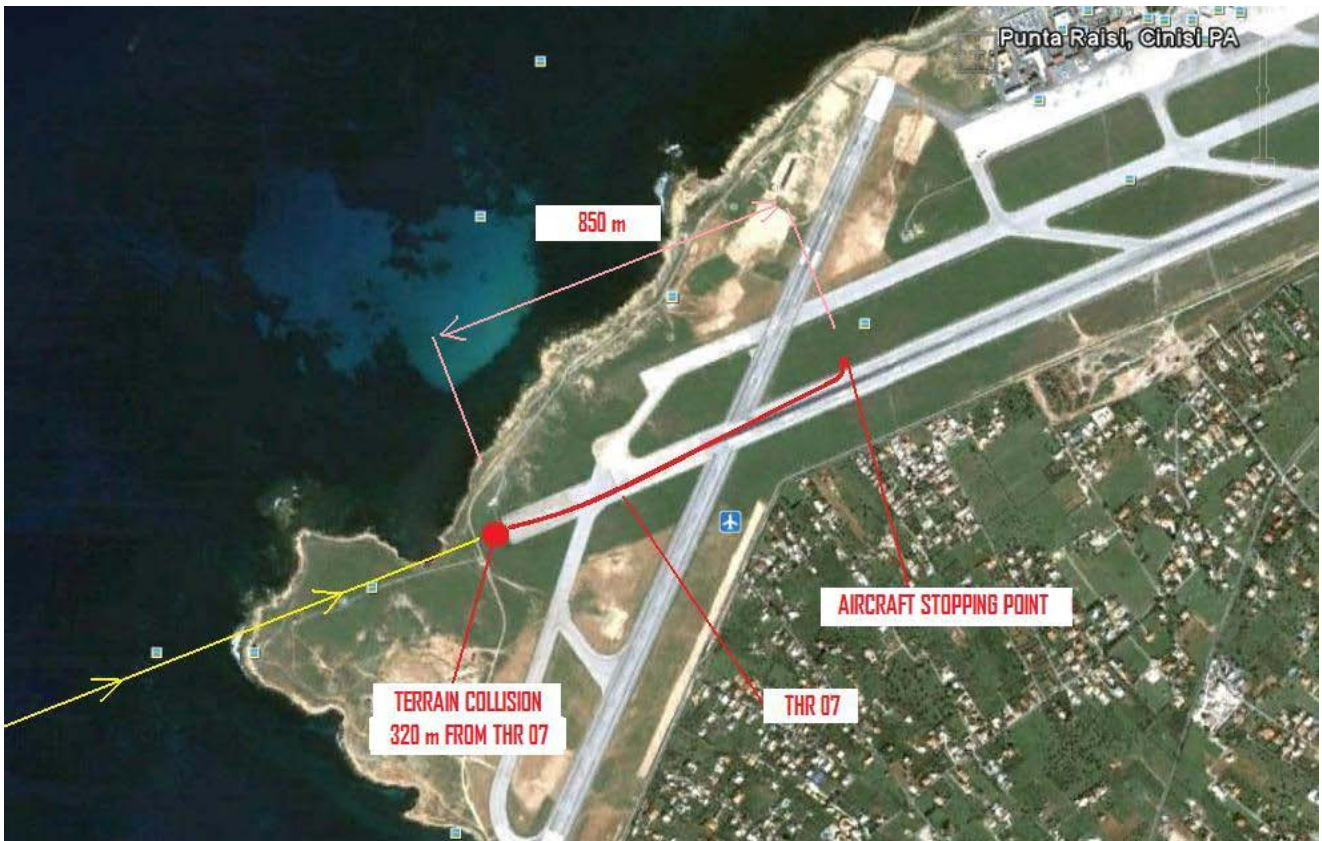
Figure 1: aircraft tracking.

At 18.08 UTC, during final approach for runway 07 with adverse meteorological conditions on Palermo airport, aircraft collided with terrain immediately before the beginning of the runway (figure 1), hit the opposite RWY localiser antenna, slid on the wet runway with main gear collapsed for about 900 meters before stopping out of the left side of the runway. Passengers evacuation was performed. Aircraft was severely damaged, very minor injuries to persons onboard.

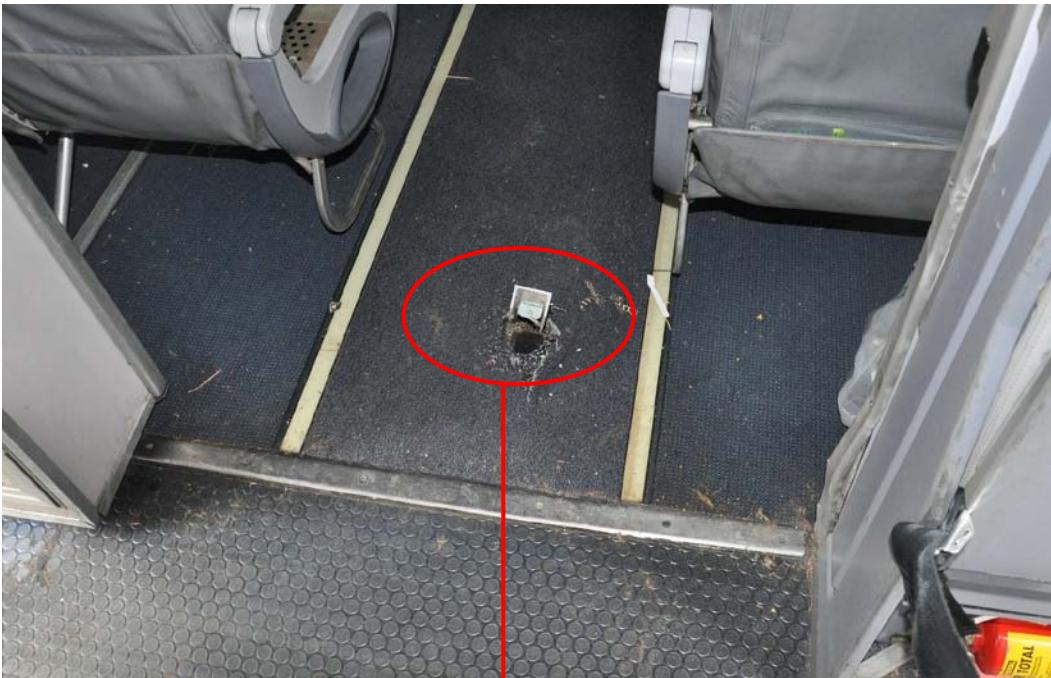
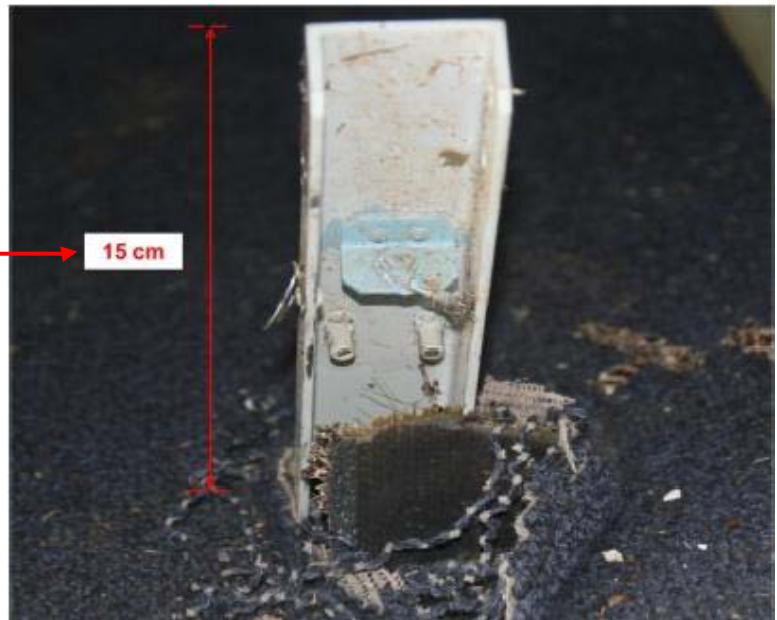
Picture 1: *cross beam* FR65.

During the ongoing investigation it has been determined that the frame “*cross beam FR65*” (picture 1 and figure 2) had penetrated the floor just in correspondence of the rear part of the escape way of the pax cabin. There is some statements who let us know that passengers fell to the ground during the cabin evacuation due to the presence of part of the FR65 coming out from the cabin floor, deeply slowing down the operation.

The position of the only evidenced damage of the pax cabin (FR65 coming out from the baggage compartment) has hindered and deeply slowed down the evacuation to the aft emergency exits and for this reason it represents one important safety issue. Same damage due to same structural component (FR65 *cross beam*) has been experienced on the Hudson River accident occurred on January 15<sup>th</sup>, 2009 (where a deep V-shaped laceration was sustained by the flight attendant as a result of the cross beam position).

Therefore injuries can be caused by the presence of the cross beam in the passenger compartment and in addition it could deeply slow down the evacuation procedure.

ANSV - considering the consequences on the survivability aspects of the pax cabin damage due to the “*cross beam* FR65” structural component (injuries can be caused by its present, after penetration, in the passenger compartment and in addition it could deeply slow down the evacuation procedure), considering the Safety Recommendations issued by NTSB on same component (A-10-92 addressed to EASA and A-10-77 addressed to FAA), considering the FAA and EASA response on them regarding the action ongoing by the manufacturer to “redesign of the *vertical beam* FR65 such that it would break instead of penetrating the floor of the aft cabin”, considering that the modification mentioned will be proposed as “product improvement” and “retrofit” - recommends EASA and FAA that:

- the aim of such modification is to avoid to establish unsafe condition for passengers and for this reason the modification must be proposed as “mandatory” on all A320-family fleet now in operation (as prescribed by EASA Part 21A.3B – «a document issued or adopted by EASA ... which mandates actions to be performed on an aircraft to restore an acceptable level of safety, when evidence shows that the safety level of this aircraft may be otherwise compromised») (ANSV-18/1836-10/1/A/11).

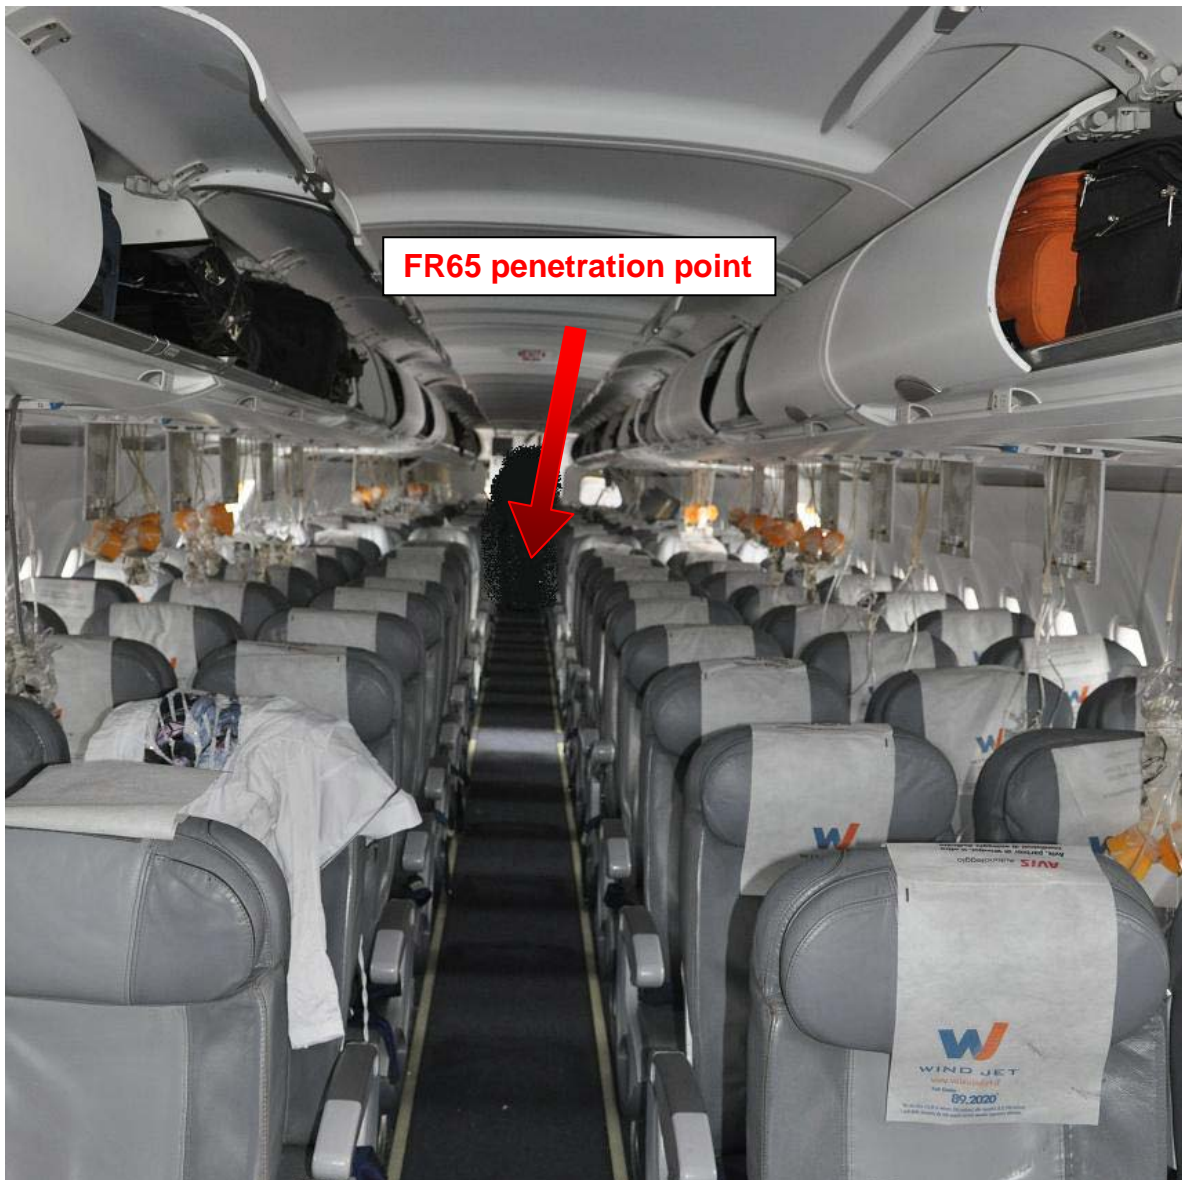
The pax cabin has showed a consistent grade of impact suppressor and only the FR65 damage became dangerous for survivability with specific mention to the passenger evacuation (picture 2).

Picture 2: pax cabin condition after impact on the accident in subject.

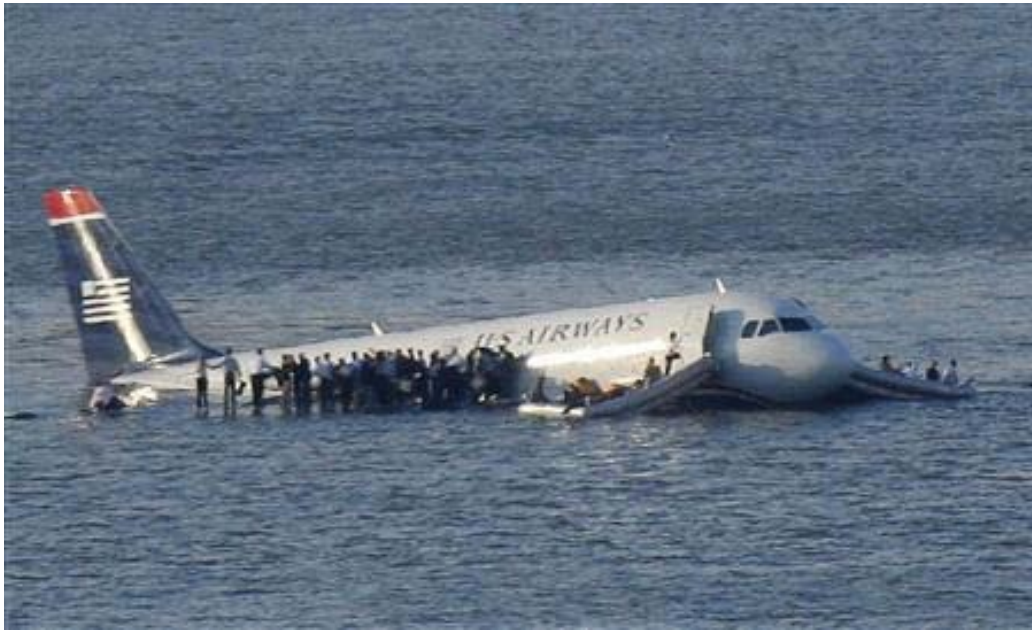
The NTSB issued on last year the Safety Recommendations A-10-92 addressed to EASA and A-10-77 addressed to FAA related to same component we are speaking about, following the investigation on the accident occurred in USA on January 15th, 2009, in which an A320-214 ditched on the Hudson River. On this accident the “cross beam FR65” come out from the pax cabin floor in the same way showed in picture 1 and the flight attendant B sustained a deep V-shaped laceration to her left shin during the accident. In that case, after ditching, people leave the aircraft from the wing and forward emergency exits due to the pitch up position of the aircraft in the river (picture 3).

Picture 3: emergency exit used on the Hudson River accident occurred on Jan 15, 2009.

For this reason the presence of the FR65 on the rear pax cabin floor did not slow down the evacuation. On the contrary, on the Palermo accident passengers used mostly the aft emergency exits because they were at ground level due to the main gear collapse (the aircraft was in a pitch up position too but on ground).
