Our ref. ANSV 1605/17

Subject: serious incident occurred on the 11th of October 2017, at Montichiari Airport (Italy), to BK117D2 registration marks I-BRXA. ANSV safety recommendations.

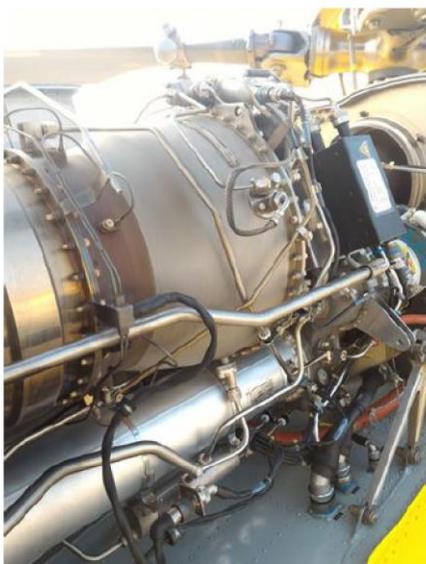
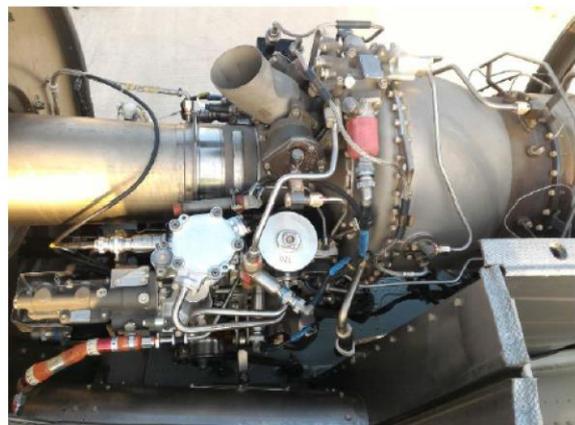
Post flight inspection revealed no signs of fire on engine 2 (picture 2) neither anything unusual on both engines. It was verified that one extinguisher bottle was discharged. Data were downloaded from the CVFDR (Combined Cockpit Voice Recorder and Flight Data Recorder), the two Engine Data Recorders (EDR) and the Aircraft Management Computers (AMC). The analysis of the abovementioned data confirmed the sequence of the events as above reported. Furthermore, it was ascertained that the engine 1 (the remaining engine after the OEI condition was established) was working correctly despite the “low RPM” indication. In more detail, in OEI condition, the red N_R law (figure 1) is used at all airspeeds.

Picture 2: post flight inspection.

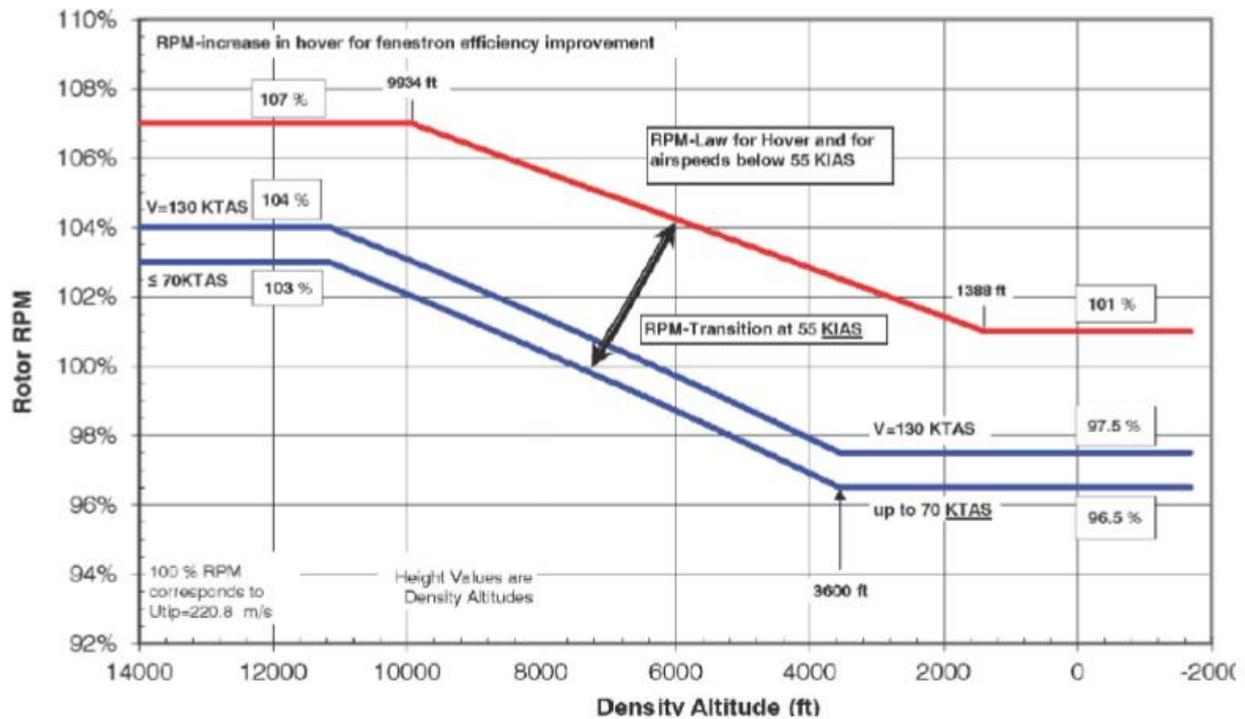
Figure 1: rotor speed governing laws.

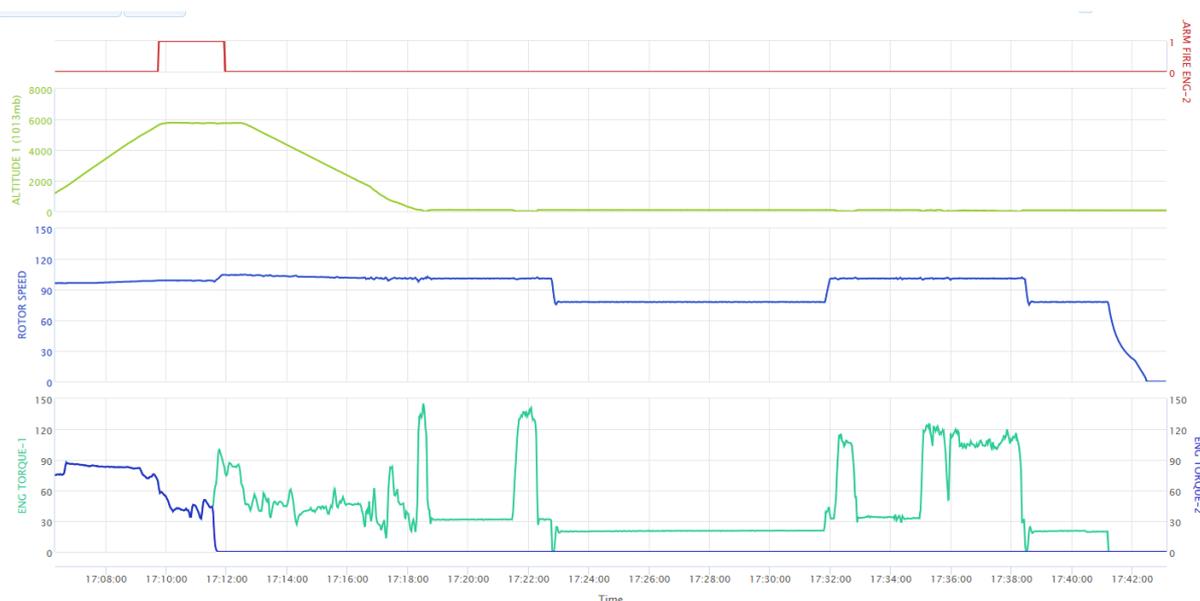
Therefore, based on the density altitude it is possible to calculate the value for the triggering of the “low RPM” signal. Comparing this calculation to the recorded main rotor speed value (blue plot in figure 2, FDR source), it is possible to verify that the behavior engine

remaining in function (N°1) after having established the OEI condition has always been within the prescribed limits despite the “low RPM” indication.

Figure 2: FDR plots. Engine 2 fire alarm (red), Altitude (green), Rotor speed (blue), Engine 1 torque (light blue), Engine 2 torque (blue).

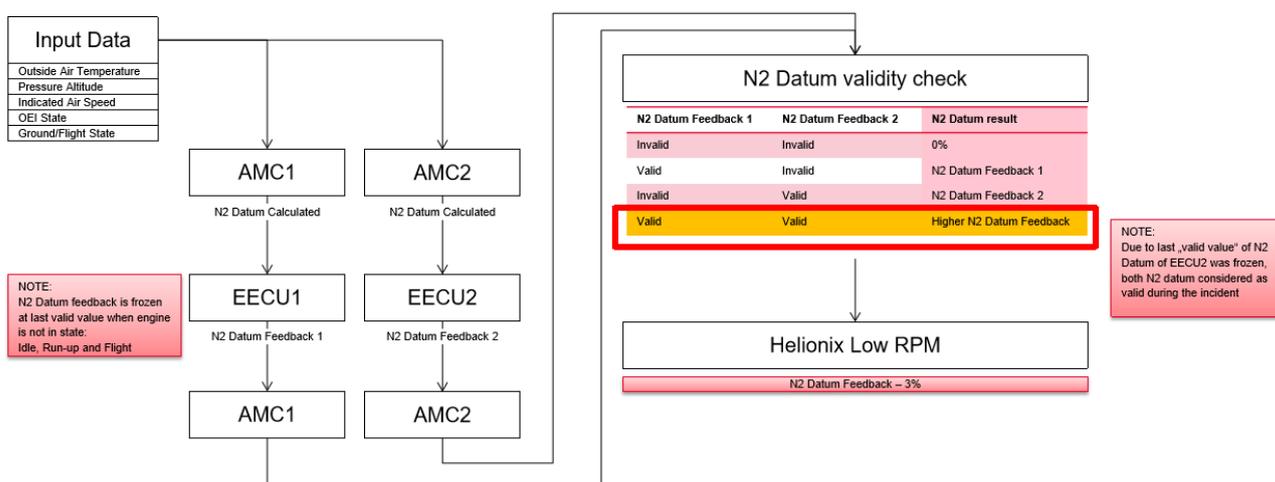
Further analysis highlighted a data handling problem between the Helionix avionic unit and the Engine Electronic Control Units (EECUs) which led to a wrong reference for the variable low rotor RPM warning, which caused the confusing indications (block diagram in figure 3): taking into account many inputs data, the AMCs provide two calculated N2 Datums (N2 is the power turbine rotation speed). These are sent to the EECUs that in turn send back to AMCs two feedback N2 Datums. Then, the N2 Datums undergo a validity check following the logic shown in figure 3. In the event flight of the BK117D2 marks I-BRXA the last valid N2 Datum value of the EECU2 was frozen and considered valid although the OEI condition was established.

Figure 3: global overview of Helionix low RPM triggering.

To verify the above explained data handling issue will be solved by means of a built-in design solution, applied to all the affected helicopters, allowing in every flight condition, including in OEI, the correct processing of the N2 Datum by all the involved avionic units.

To verify that, in the meantime a design fix of the above explained data handling issue will be applied to all the affected helicopters, the crew operating the BK117D2 will be quickly informed that in OEI condition a misleading and false “low RPM” indication (audio and visual) can be received.

To verify that, in the meantime a design fix of the above explained data handling issue will be applied to all the affected helicopters, a detailed procedure will be quickly provided to the crew in order to clarify how to deal with a “low RPM” indication (audio and visual) during OEI condition. This procedure has to allow a rapid and reliable evaluation of the “low RPM” indication trustworthiness.
