# PRELIMINARY REPORT

ACCIDENT aircraft AW139 registration marks I-TNCC, Cima Nambino (TN), 5<sup>th</sup> of March 2017

### AgustaWestland AW139 registration marks I-TNCC

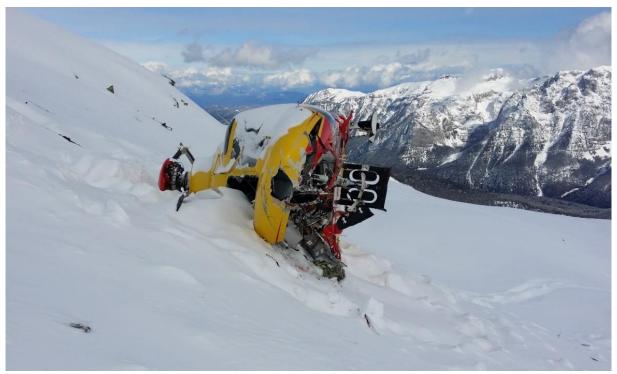
Nature of Damage Aircraft: main rotor, front cabin, right engine, tail rotor, tail rotor

transmission shaft, nose landing gear, hoister (photo 1 and photo

Photo 1: wreckage front view.

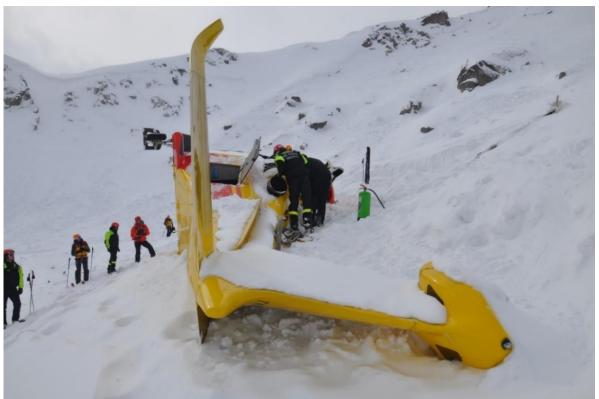
Photo 2: wreckage rear view.

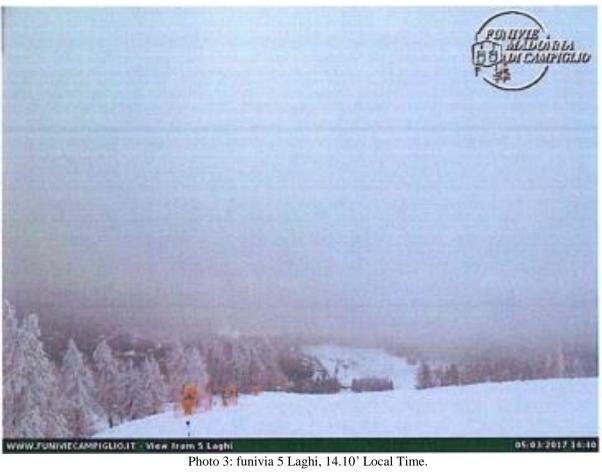
Pictures from webcams of nearby the ski areas one hour after the accident were collected: photo 3, funivia 5 Laghi, about 3 km from the impact location; photo 4, Folgarida, about 7 km from the impact location; photo 5, Pradalago, about 2 km from the impact location; photo 6, Campo Carlo Magno, about 4 km from the impact point.

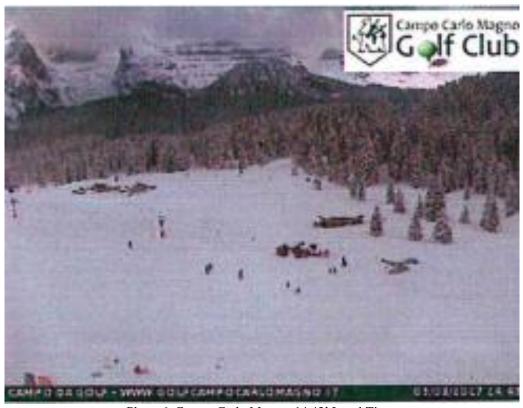
Photo 6: Campo Carlo Magno, 14.43' Local Time.

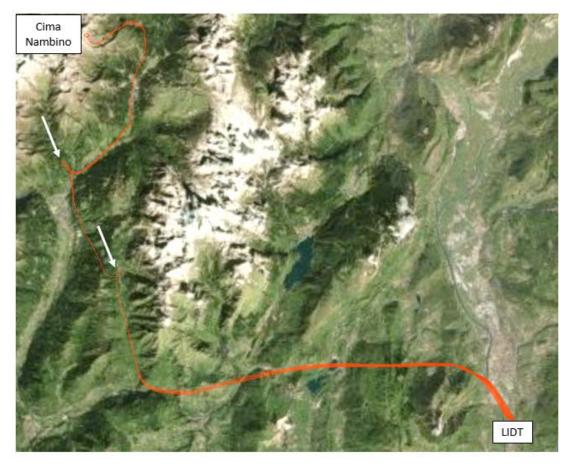
Figure 1: AW139 I-TNCC trajectory.

The I-TNCC crew then landed in Trento airport (LIDT) at 11.52'09" for fuel supply and to take on-board the required personnel for the HEMS operation. At 11.56'29", the I-TNCC took off and headed toward Cima Nambino following the trajectory depicted in figure 1, reconstructed from the FDR<sup>9</sup> recorded data.

Two circling maneuvers were performed before arriving to Cima Nambino (arrows in figure 1). The flight lasted about 23'.

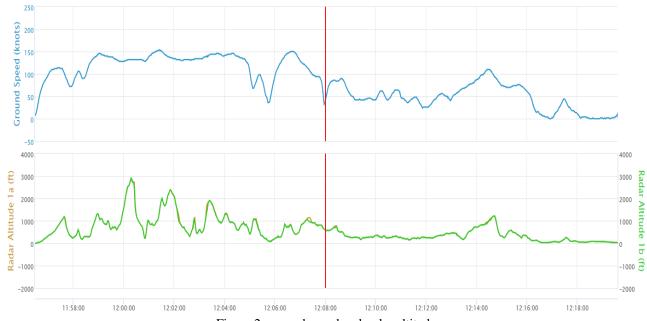
Figure 2: ground speed and radar altitude.

During the first half of the flight, the ground speed was maintained between 130 kts and 150 kts (figure 2), while the radio altitude was between 220 ft and 2870 ft. During the second half of the flight (figure 3), the speed decreased being between 110 kts and 26 kts. Also the height was lower on average, between 1220 ft and 28 ft, spending most of the time between 600 and 200 ft.

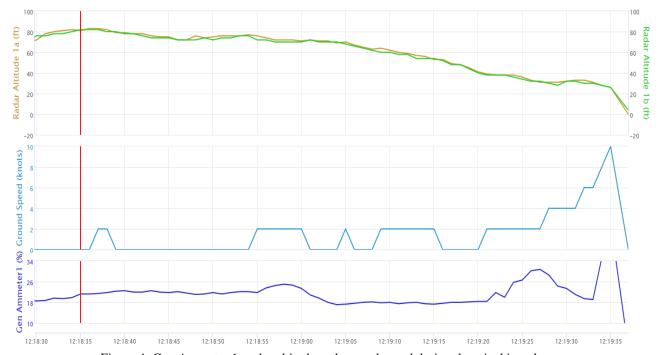
Figure 4: Gen Ammeter 1, radar altitude and ground speed during the winching phase.

The FDR parameter "Gen. Ammeter" provides indirect information of the winch functioning: when load is applied, then the load percentage increases. Based on this parameter and on the CVR recordings synchronized to the data, it is possible to set the start of the winching phase at 12.18'35" (red line in figure 4). At that time, the ground speed was 0 kts and the radio altitude was 81 ft (figure 4). The magnetic heading was maintained within 258° and 262° up to the ground impact. The helicopter attitude is depicted in figure 5. During the winching phase, the recorded collective pitch was kept within 67% and 74% (figure 6).

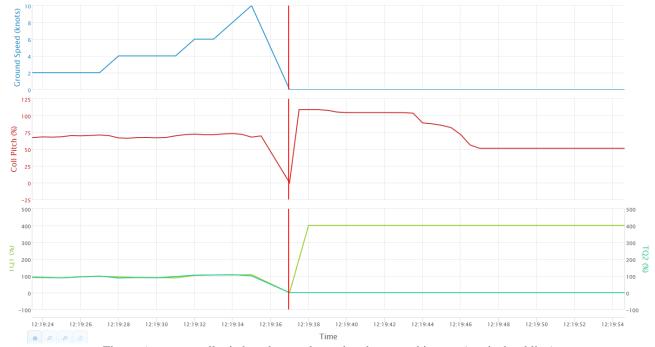
Figure 6: torque, coll. pitch and ground speed at the ground impact (vertical red line).

At 12.19'37" a sudden variation of most the parameters is recorded: this is the time of the ground impact. In detail, a slight decrease in torque on both engines is followed by an even steeper decrease of the torque on the engine 2, that went to 0, and a fast increase of the torque on the engine 1 (figure 6). This last effect is reasonably due to the main rotor blade impact to the ground. Attitude shows abrupt changes followed by a steady state as well as accelerations (figure 7 and figure 8). However, these remain below 2,3 "g": as per specification, the ELT<sup>11</sup> did not intervene.

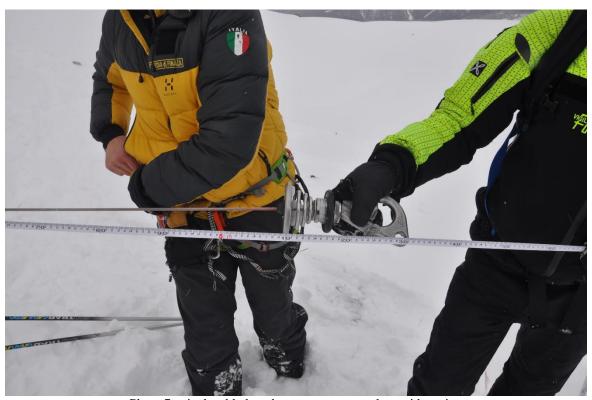
The length of the winch cable out of the helicopter was measured first on the accident site, resulting 5,10 m (photo 7). This measurement was repeated after the wreckage was moved into a hangar, resulting at that time 8,35 m (photo 8). This last measurement is coherent to the recorded radar altitude. Such a big difference between the two measurements is because when

on the accident site, part of the cable was entangled under the wreckage.

Photo 7: winch cable length measurement on the accident site.

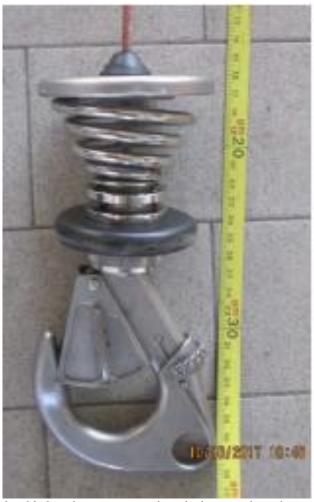
Photo 8: winch cable length measurement into the hangar where the wreckage is kept.
