# **PRELIMINARY REPORT**

## **ACCIDENT**

**aircraft Cessna 560 XLS+ registration marks OE-GES,  
Milan Malpensa Airport (Italy),  
5<sup>th</sup> of September 2019**

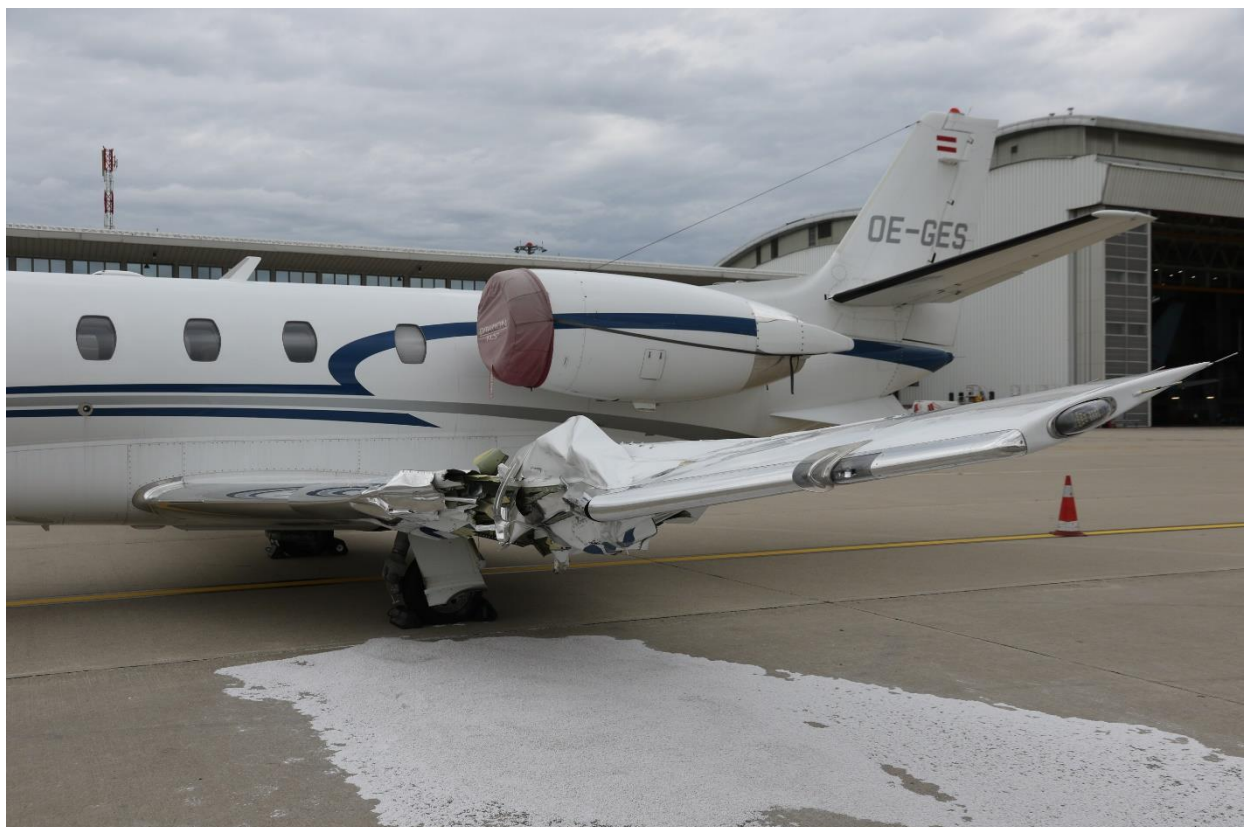
| <b>Nature of Damage</b> | Aircraft: left wing (photo 1 and photo 2).<br>Tractor: destroyed (photo 3 and photo 4). |

Photo 1: aircraft left wing damaged.

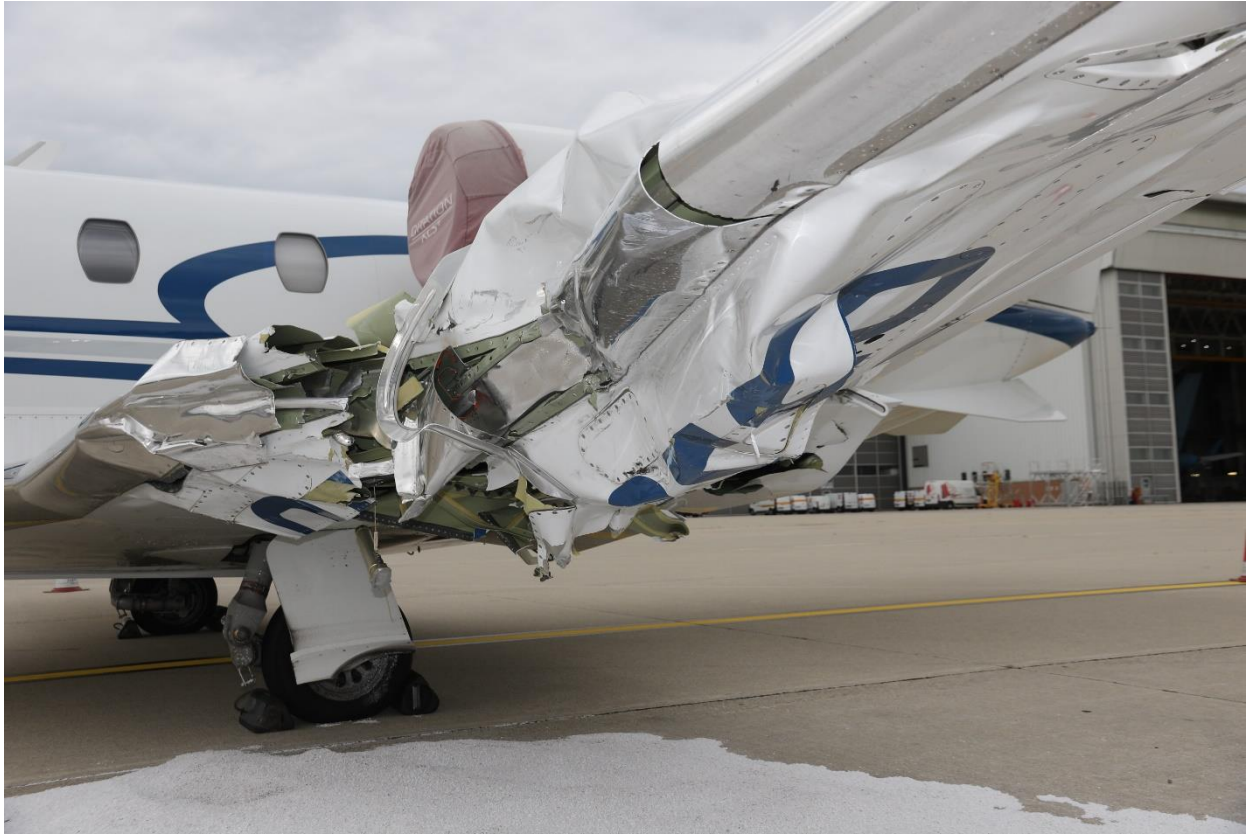
Photo 2: left wing damage details.

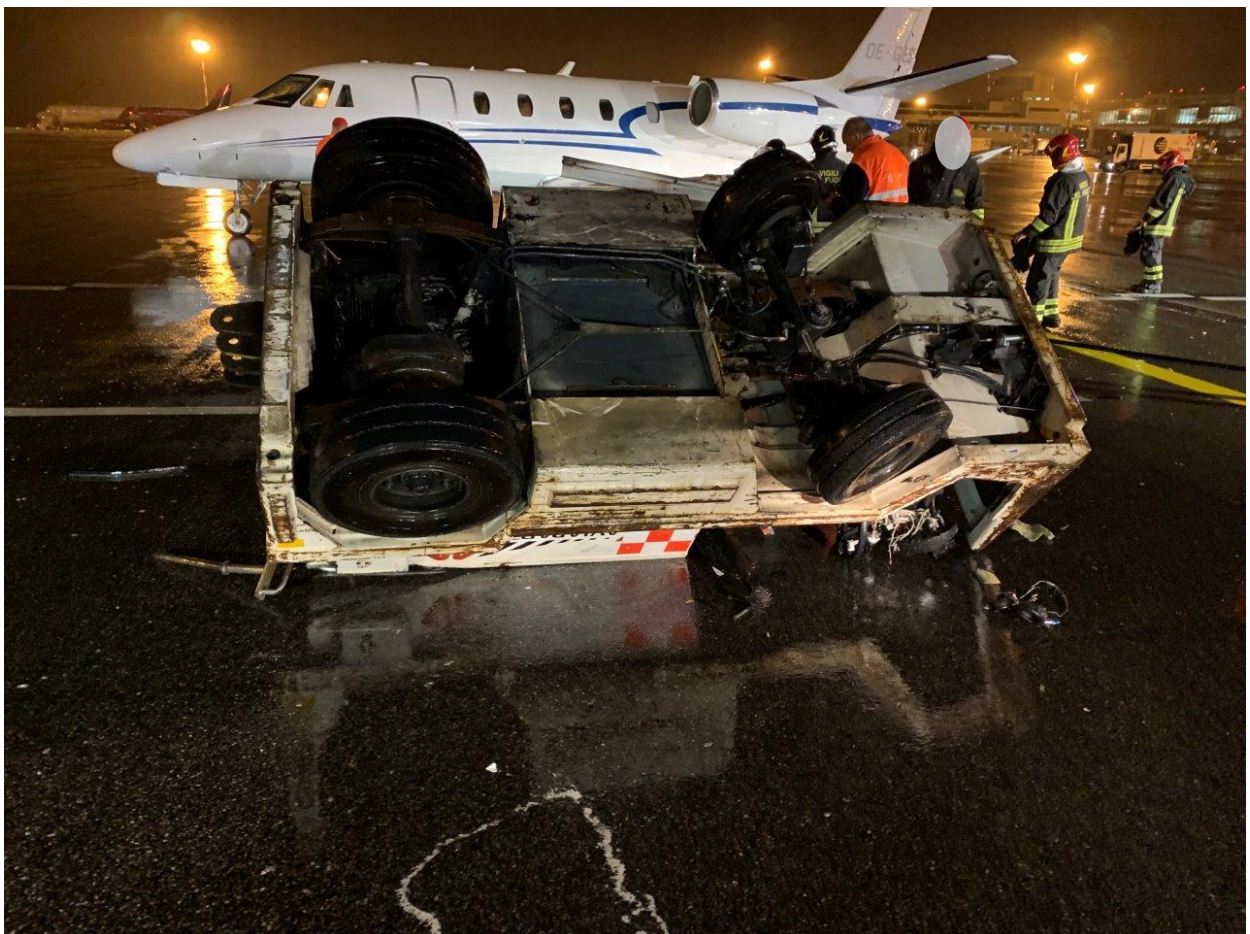
At the impact, the baggage electric tractor rolled left about its longitudinal axis and destroyed (photo 3 and photo 4). The tractor driver sustained serious injuries and was hospitalized.

Photo 3: baggage tractor after the impact.

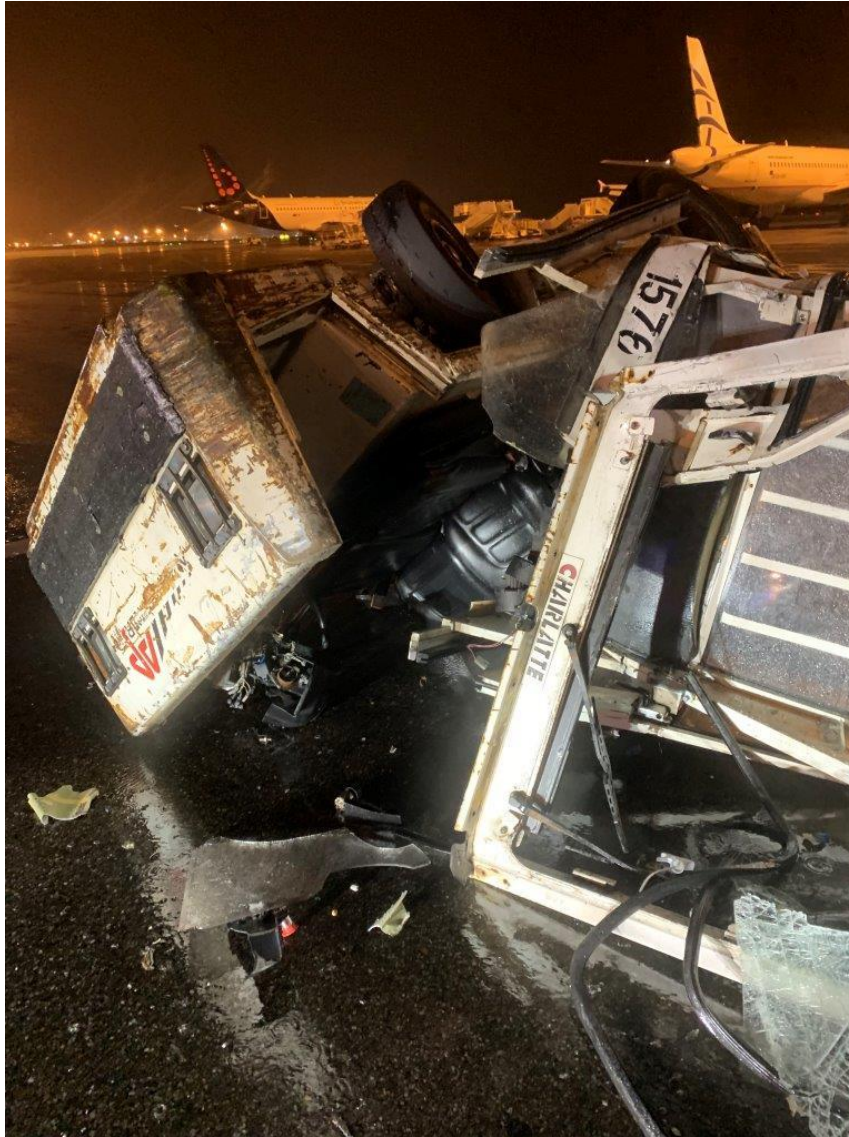
Photo 4: baggage tractor damage details.

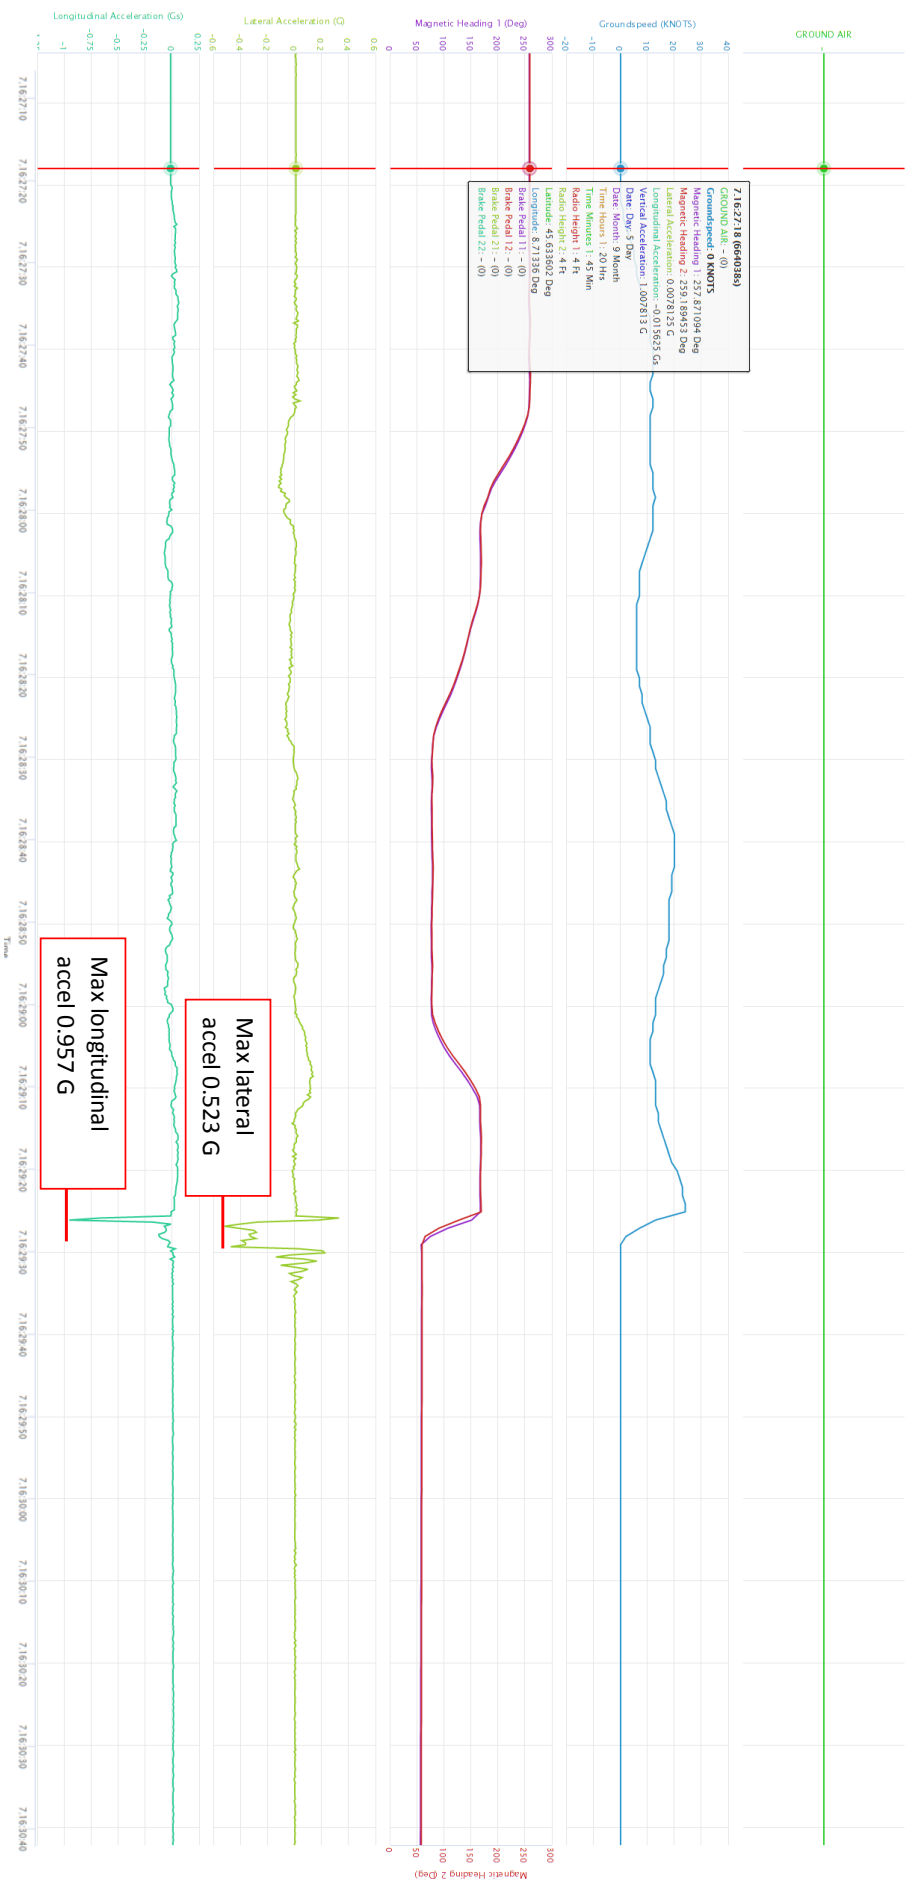
Figure 2: OE-GES FDR data – Start taxiing phase (Ground/Air, Groundspeed, Mag HDG1, Mag HDG2, Lateral Accel, Longitudinal Accel).

The maximum values of the lateral and longitudinal accelerations are boxed in figure 2.

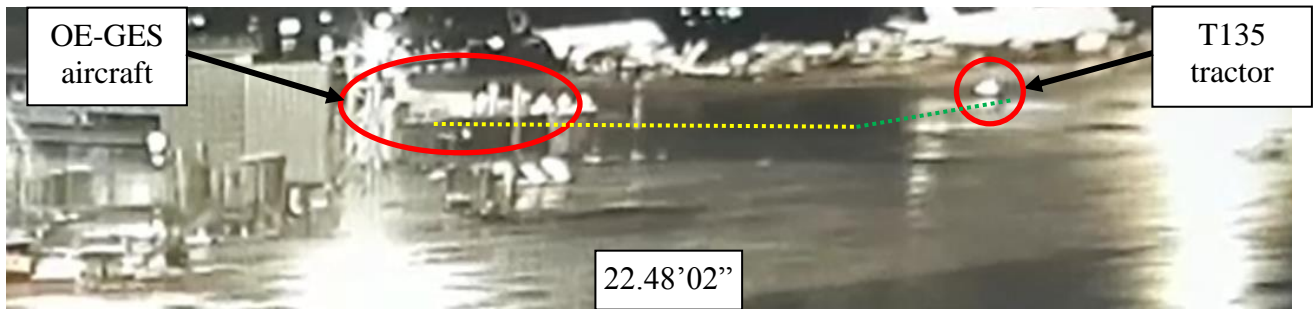
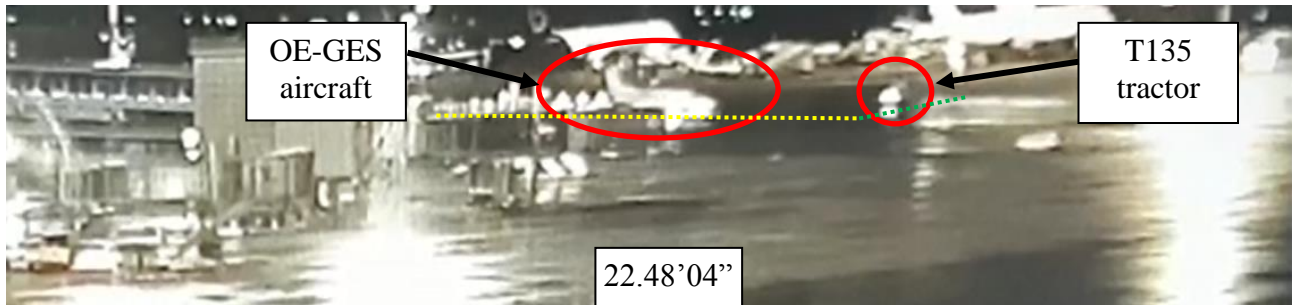
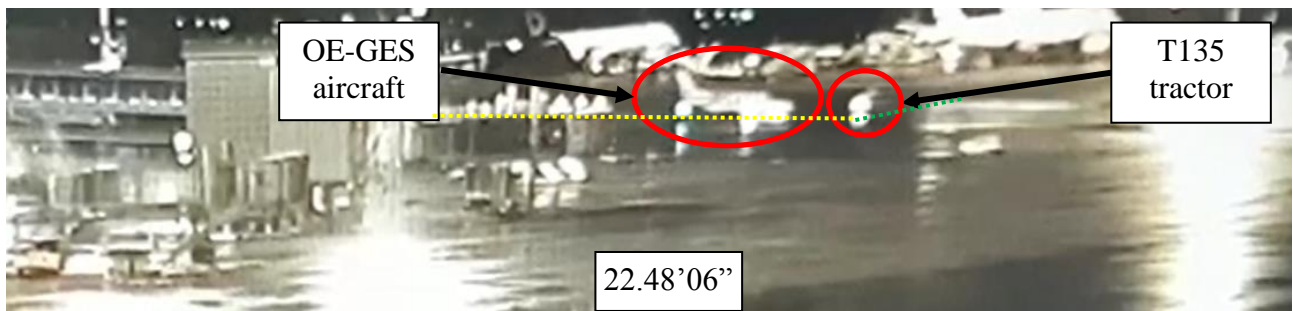
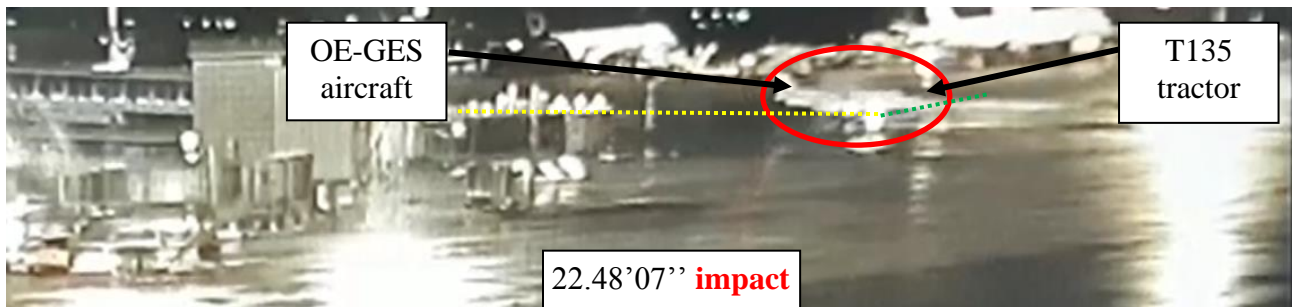
Photo 5: accident event sequence CCTV screenshot (hours expressed in “CCTV local time”).

The accident event sequence can be confirmed also by the CCTV<sup>12</sup> video of the airport, which showed that both the tractor and the OE-GES aircraft were continuously proceeding respectively within the vehicular path demarcation and on the apron taxiway Yankee, until the impact occurred (photo 5).
