SAFETY RECOMMENDATION

Subject: Boeing 737-700, registration marks OY-MRG. Serious incident occurred on June 13th 2009 at Firenze airport (LIRQ), Italy.

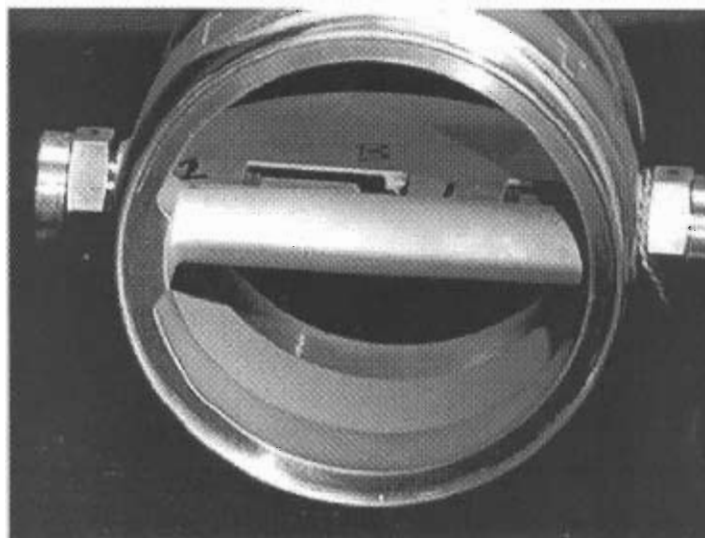
The root of the problem was identified in the bleed air check valve (P/N 3202222-1) stuck in the open position. The valve is designed to prevent reverse flow from 9th stage into the 5th stage of the High Pressure Compressor.

P/N 3202222-1 bleed air check valve.

- 1) In just over a year, the 737 NG fleet has experienced five engine shutdowns that were all caused by the 5th stage bleed air check valve stuck in the open or partially open position.
- 2) With the 5th stage bleed air check valve stuck in the open position, an engine compressor surge can occur as 9th stage bleed air backflows into the engine HPC 5th stage that typically occurs during an engine acceleration while at low power.
- 3) Boeing examined four 5th stage bleed air check valves of the five reported events and all four were found stuck in the open position due to fractured bushings in the valve flapper butterfly plates.

- to consider requesting Boeing to build-up a pro-active procedure allowing flight crews to identify and manage the event of CFM56-7B22 engines 5th stage bleed air check valve stuck in the open position (ANSV-6/625-09/1/09);
- to verify the on-going manufacturer investigation process on the involved P/N, in order to determine if the failure is associated with the design of the part or with a production deviation occurrence which affects a limited number of Serial numbers.
Furthermore to ensure that the affected parts are replaced either if they are identified to belong to a specific batch or if is a fleet wide problem (ANSV-7/625-09/2/1/09).
