SAFETY RECOMMENDATION

Subject: Boeing 737/8AS, registration marks EI-CSN. Accident occurred on June 25th, 2007, at Treviso airport (Italy).

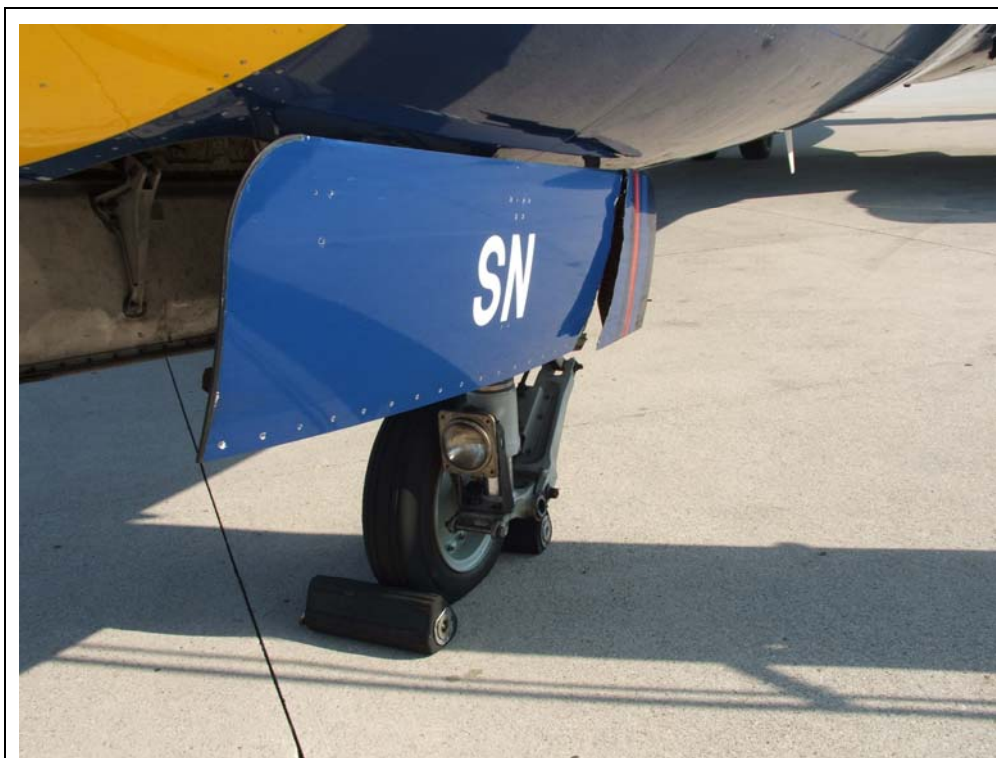
On June 25th 2007, at 15.46 UTC, the aircraft B737/8AS, registration marks EI-CSN, operating flight FR 9513 from Gerona (LEGE) to Treviso Sant’Angelo (LIPH), suffered the NLG left wheel separation during the landing roll.

Photo n. 1: EI-CSN as landed at LIPH.

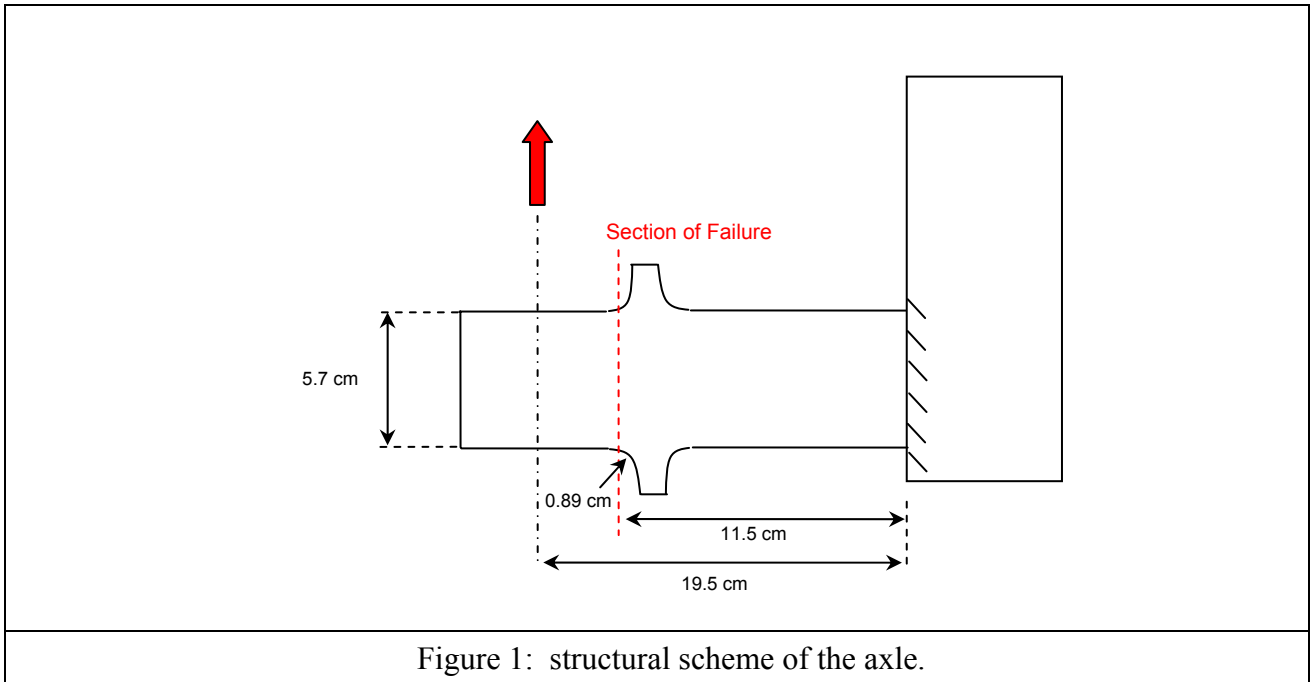
The separation of the wheel was due to the structural failure of the NLG axle, part of the assy inner cylinder P/N 162A1120-2, s/n 5018.

The component, made of high strength steel, AISI 4340M or 300M (UTS 1860÷2070 MPa) failed on its left side (scheme in Figure 1), where the wheel was installed, at 15.309 Cycles Since New (CSN), about 1/5 of its life (75.000 cycles).

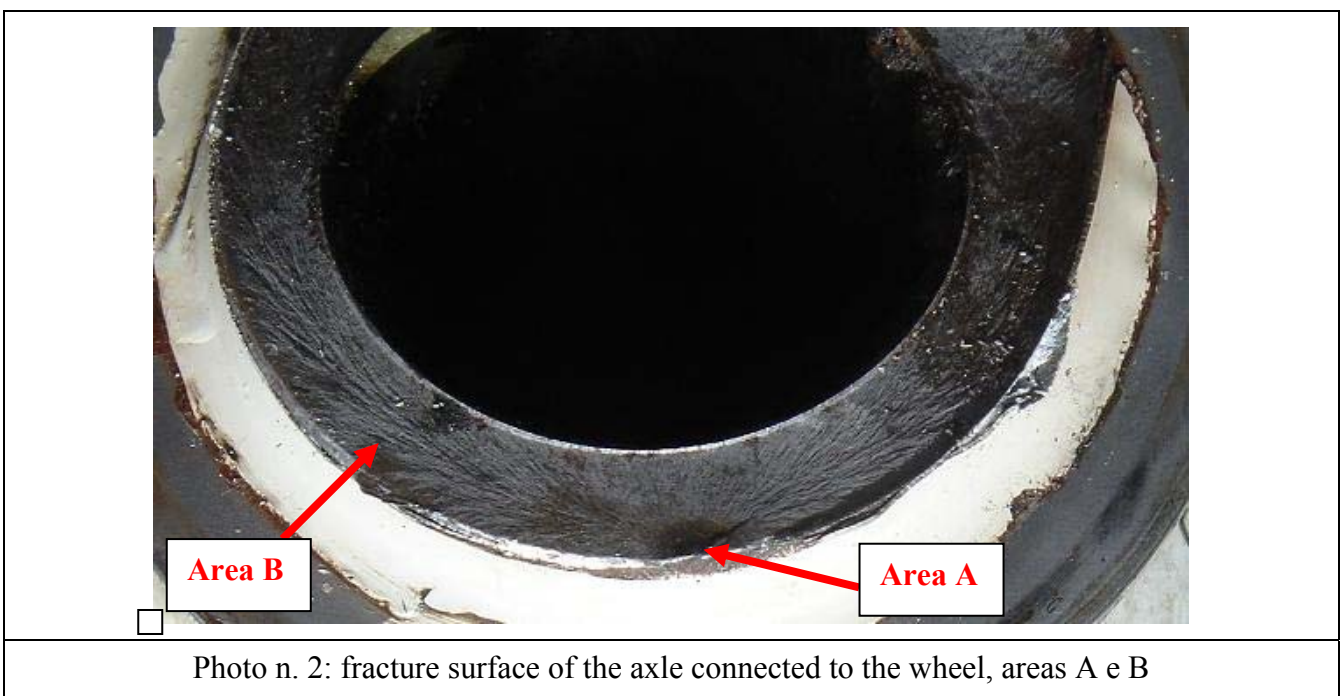
The fracture surface (Photo n. 2) appears exempt from plastic deformation, in agreement with the high strength and consequently brittle nature of the material.

- Area A, dark brown and semi-elliptical or fan shaped, which covers about 5% of the whole fracture surface. This area is located at 6 o'clock position, therefore in the lower part of the axle, where the highest tensile stresses, due to the flexional behaviour imposed by the weight, are concentrated (see scheme in Figure 1). This area is associated to the progressive crack that developed till the final breakage occurred;
- Area B, light grey and plenty of chevron marks, typical of dynamic failures of brittle materials, which covers the remaining 95% of the fracture surface. It is associated to the final and instantaneous breakage of the axle.

This facts show that the axle failure proceeded in two different steps: the first when the progressive crack developed from the high stress region till covering a reduced section of the axle, and the second, covering a much wider area when the final instantaneous breakage took place. During this final breakage, the association of the impact forces due to the landing explains the pattern of the upper part of the fracture surface, that doesn't appear flat and in-plane with the lower part.

With respect to the progressive crack in Photo n. 2, the brown colouration of the area is likely due to a corrosion phenomenon taking place.

This evidence supports the deduction that the structural failure was probably due to a Stress Corrosion Cracking (SCC) phenomenon initiated from general corrosion taking place on the external surface of the axle.

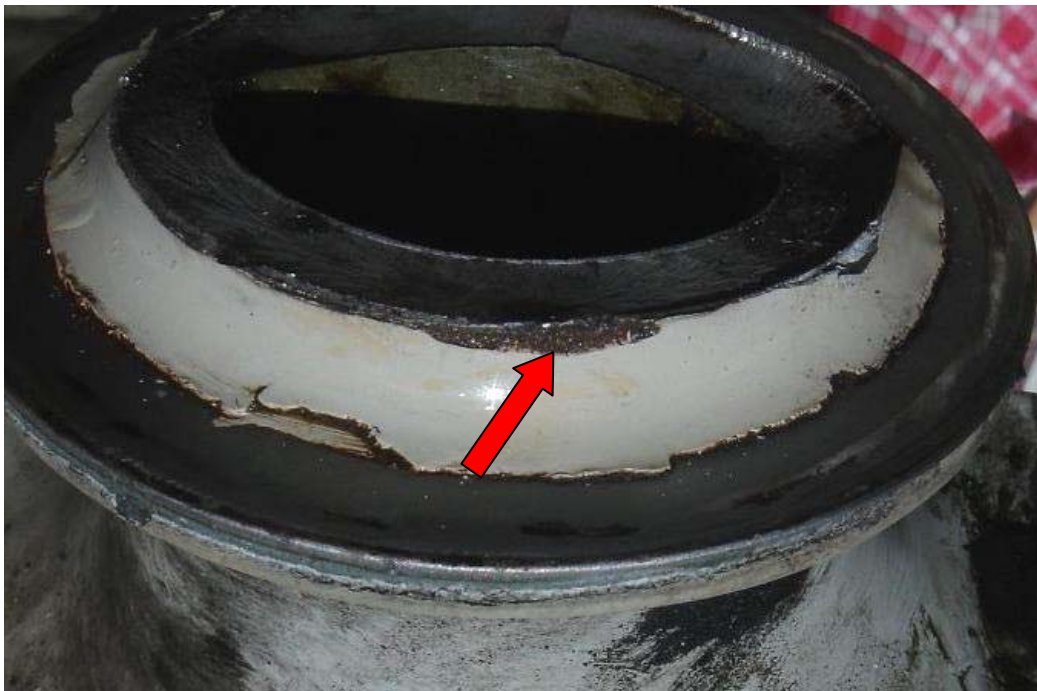
As a matter of fact, when observing the external surface of the component near the crack initiation region, the presence of an uniform corrosion process, accompanied by some pitting, was found (arrow in Photo n. 3).

Photo n. 3: presence of uniform corrosion on the external surface, right where the progressive crack initiation.

Currently, stress corrosion cracking is thought as the most probable failure mechanism, since an uniform corrosion attack was observed in the region of the external surface where the highest stresses are concentrated.

perform an *una tantum* visual inspection on the NLG axles installed on all the 737 models currently equipped with similar component. The inspection should be accomplished by preliminary removal of the spacer and then particularly focused on verifying any presence of corrosion at the 6 o'clock position after removal of the spacer. If corrosion is detected in that specific area an additional NDT for cracks (dye penetrants or MPI) has to be implemented.
