**SAFETY RECOMMENDATION**

Subject: accident occurred on Lasa (Bolzano, Italy) airfield to the helicopter AS350 B2, registration marks I-AIRY, on May 16th, 2011.

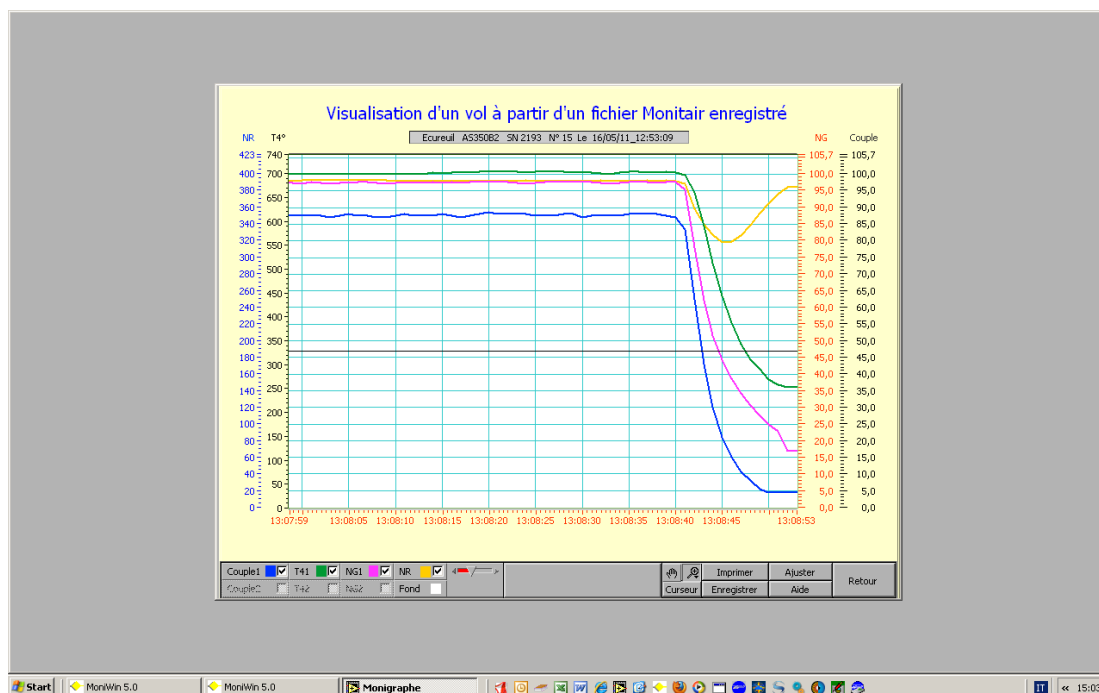
Picture 2: Data showed by “Monitair”.

The “Monitair” system evidenced an in flight shut down of the engine (picture 2).

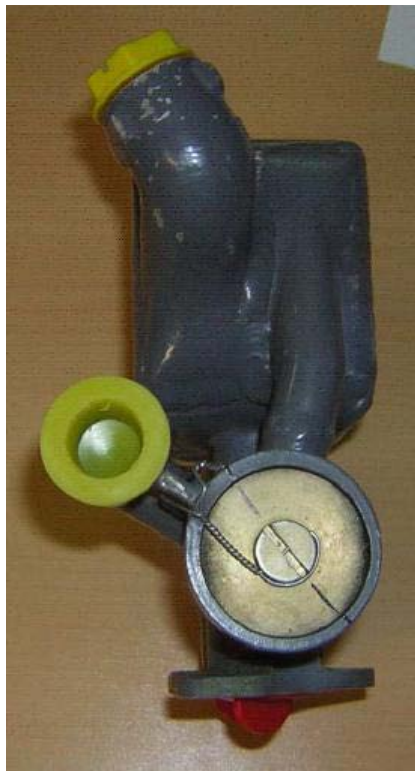
Picture 3: “oil to fuel heater”.

The helicopter is equipped with the “oil to fuel heater” P/N 10544D (P&WC P/N3032708), s/n 1993, that is part of the optional Service Bulletin Nr. 28.00.09.

The test on the fuel filter revealed no discrepancy while the test on the “oil to fuel heater” showed a deep reduction between the fuel in to out pressure:

- test with fuel flow 80l/h: Inlet pressure 30 kPa; Outlet pressure 8 kPa (delta P=22 kPa);
- test with fuel flow 180 l/h: Inlet pressure 122 kPa Outlet pressure 1kPa (delta P=121 kPa).

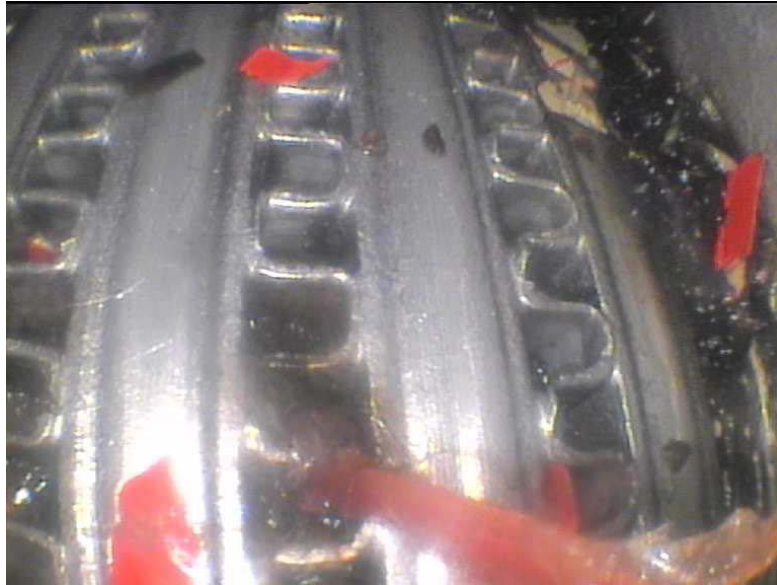
They are values not acceptable for the normal operation of the engine, so a boroscope inspection has been performed on the first part of the inlet section of the component revealing the presence of pollution and debris (picture 4). Following these new evidences, it has been decided to proceed with a test of the “oil to fuel heater” on an engine test bench equipped with fuel filter and FCU, to the engine manufacturer facilities.

Picture 4: pollution and debris found within the “oil to fuel heater” inlet duct.

The abnormal pressure drop inside the fuel heater induced cavitation phenomena on the FCU and explains the engine in flight shut down.

The lack of maintenance task on the fuel flow test or on a scheduled cleaning related to the “oil to fuel heater” appears to be linked to the conditions of the component.

The investigation and the analysis performed demonstrate that the “oil to fuel heater” clogging was the cause of the engine in flight shut down. The lack of specific maintenance task on it has contributed to make not possible to discover the problem before the event.

- an additional inspection should be asked as soon as possible to the Operators/Owners of the helicopter type in subject now in operation (equipped with the optional Service Bulletin Nr. 28.00.09), in order to check the “oil to fuel heater” component for pollution presence and for correct fuel flow values (ANSV-16/726-11/1/A/11);
- a scheduled check should be implemented within the maintenance program of the helicopter type in subject (equipped with the optional Service Bulletin Nr. 28.00.09) in order to check the fuel flow of the “oil to fuel heater” component during its operative life and in order to perform its cleaning (ANSV-17/726-11/2/A/11).
