# **PRELIMINARY REPORT**

**SERIOUS INCIDENT**  
**aircraft B787-8 registration marks LN-LND,**  
**Rome Fiumicino International Airport (Italy),**  
**10<sup>th</sup> of August 2019**

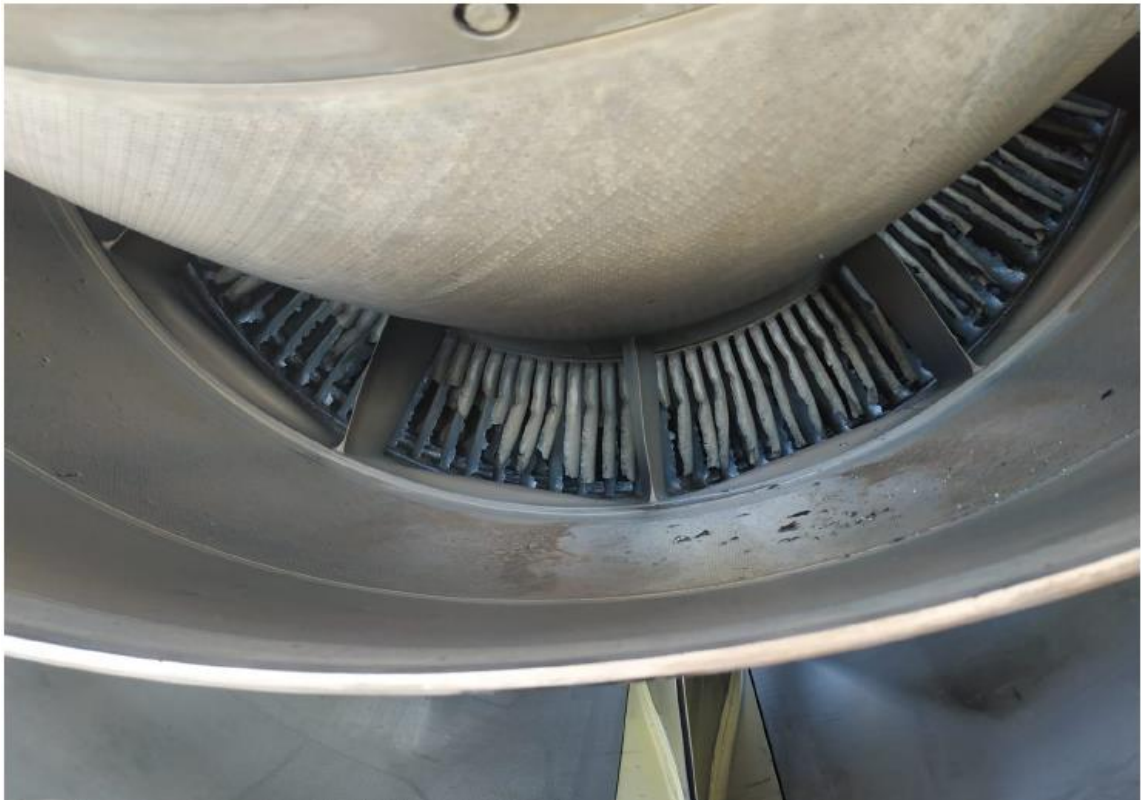
Photo 2: external evidence of left engine damage.

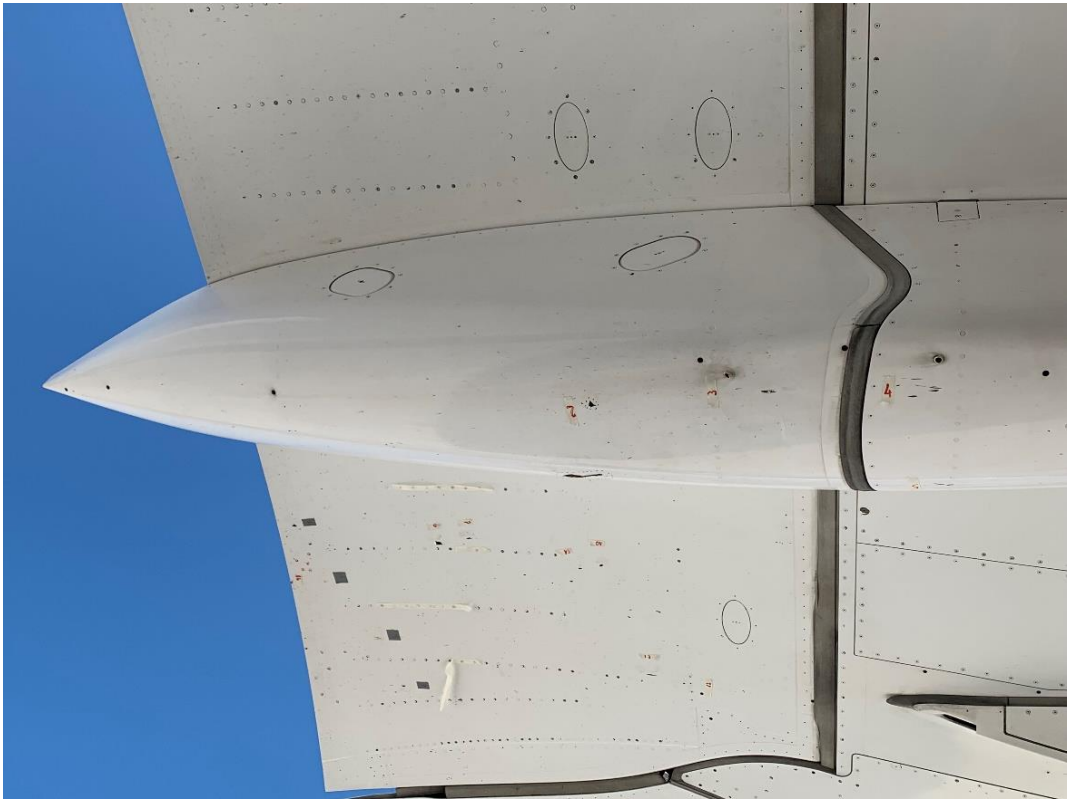
Photo 3: aircraft damage.

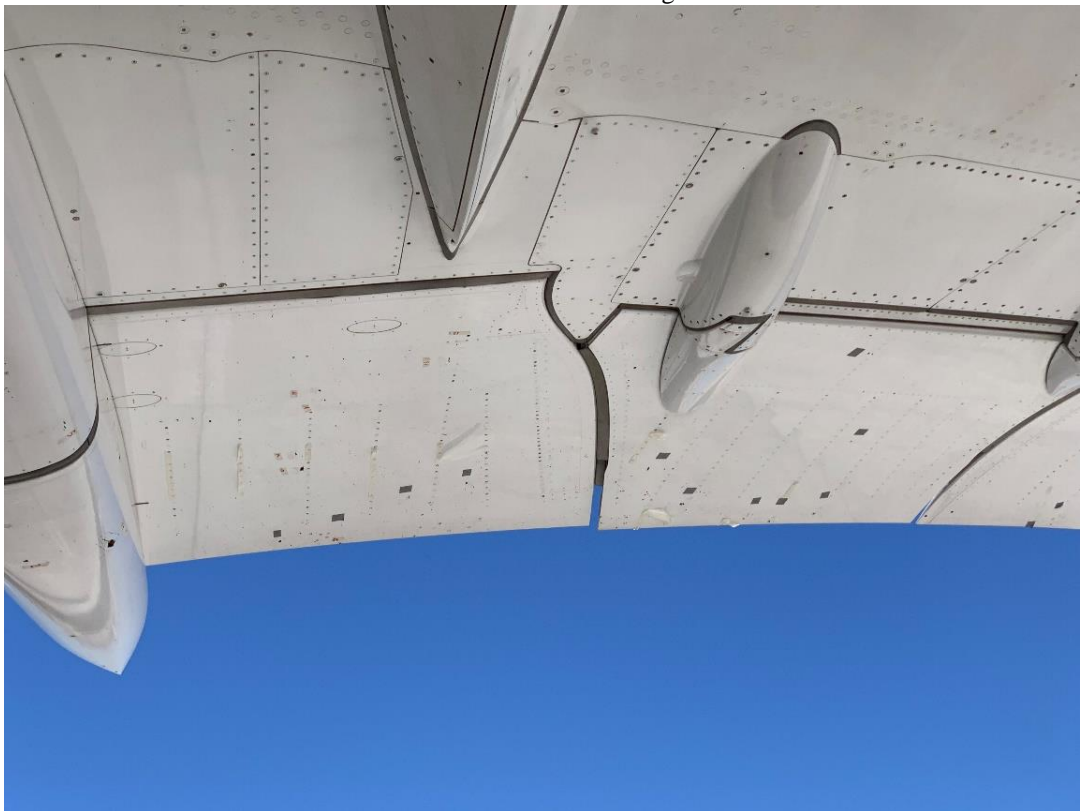
Photo 4: aircraft damage.

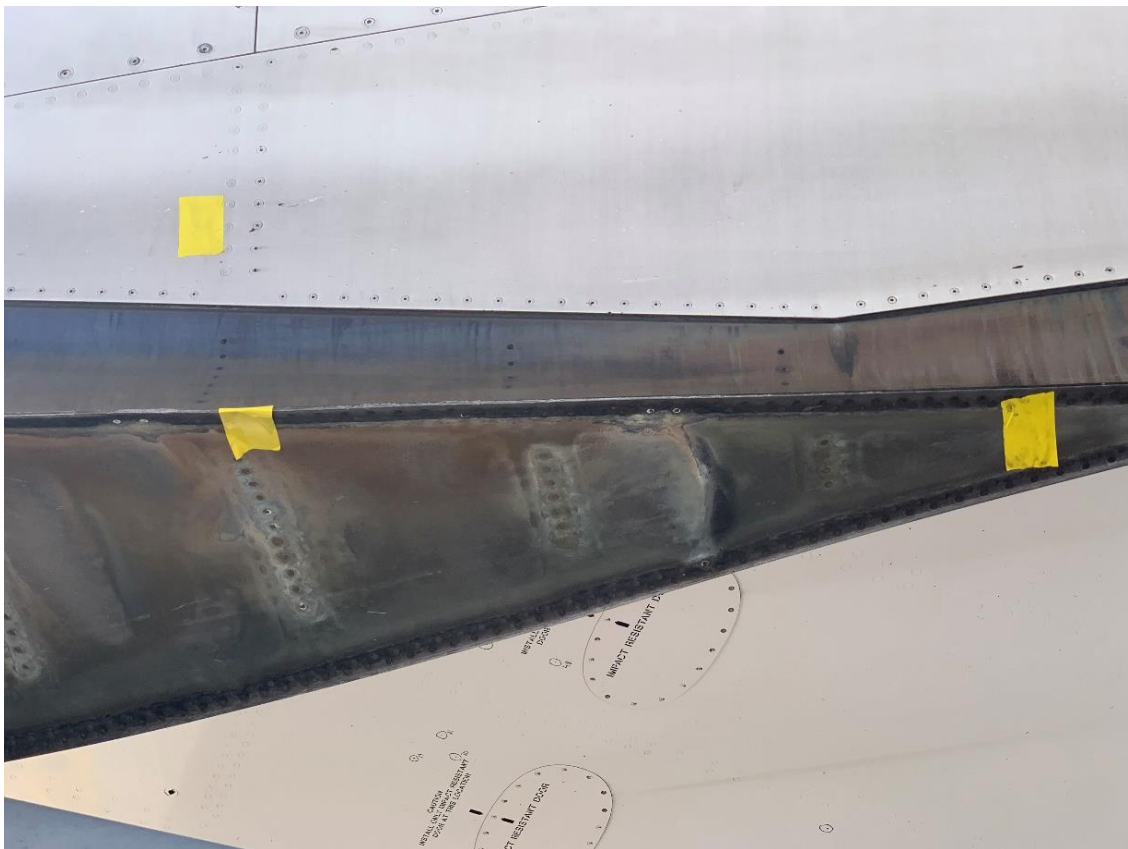
Photo 6: aircraft damage.

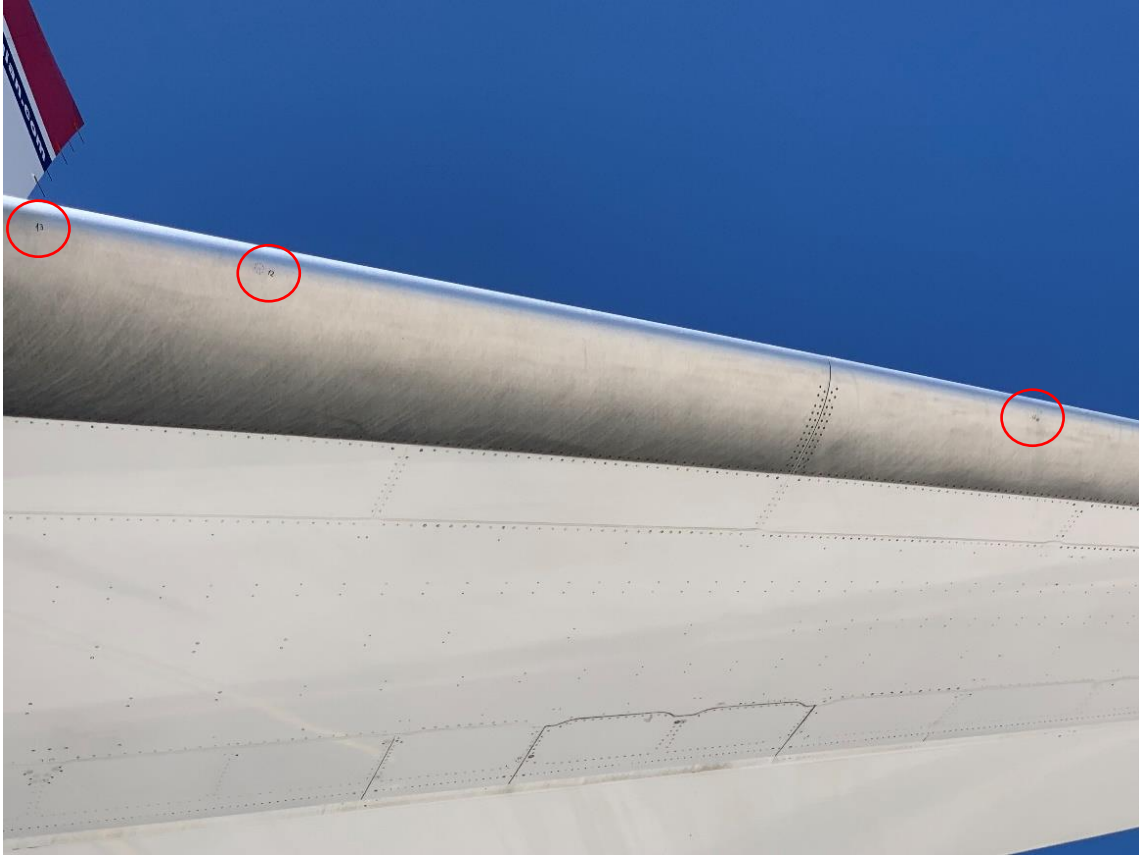
Photo 7: aircraft damage, horizontal stabilizer.

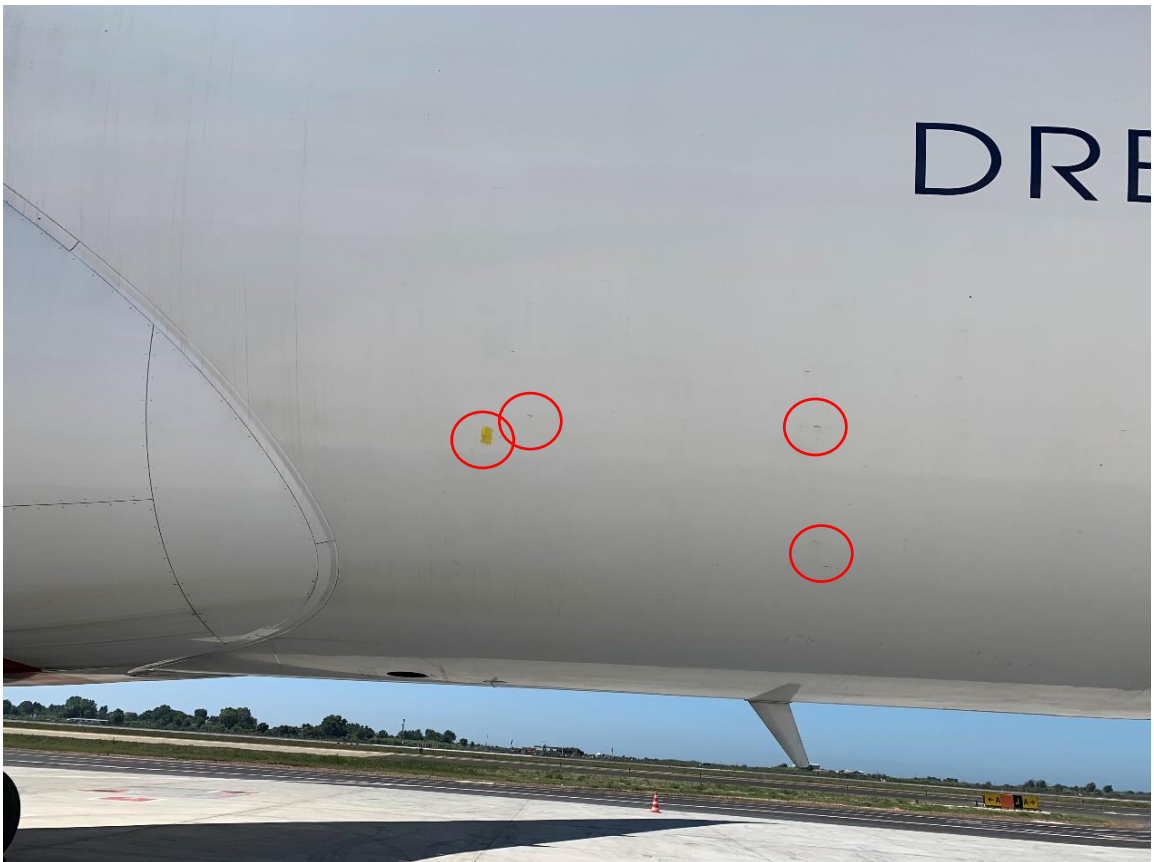
Photo 8: aircraft damage, fuselage.

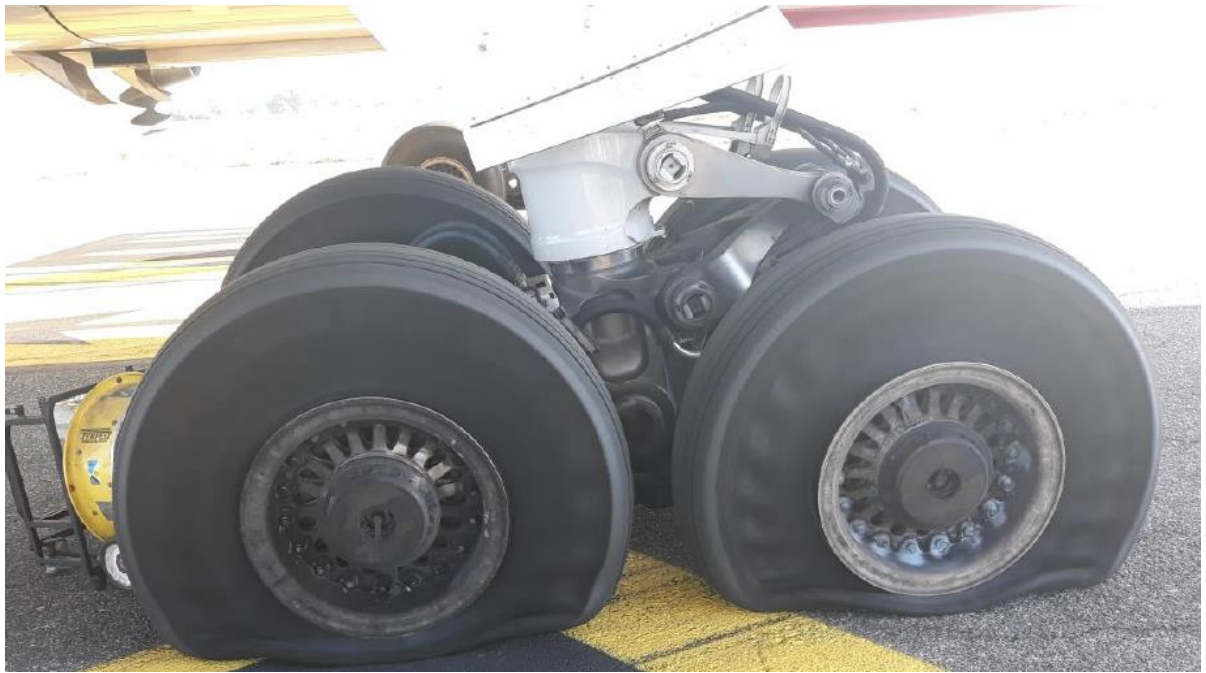
Photo 9: deflated left landing gear tires.

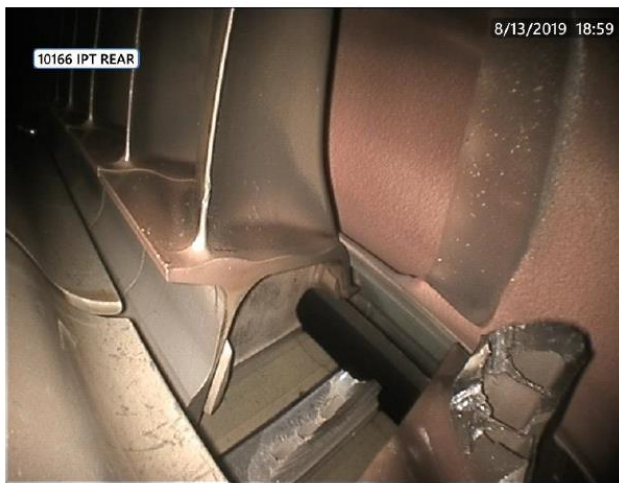
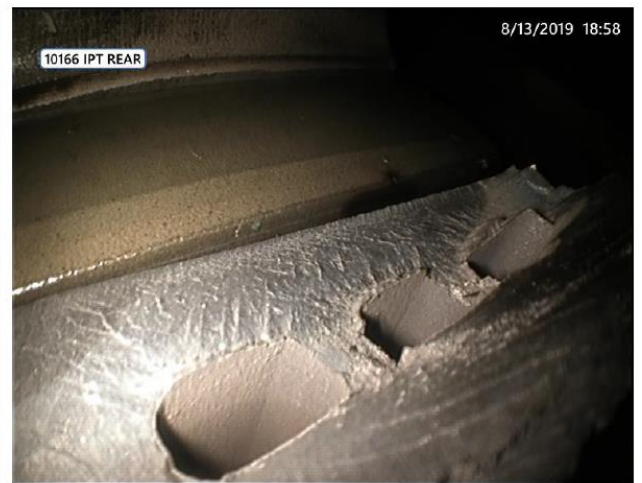
Photo 12: fracture surfaces of the IPT blades found broken.

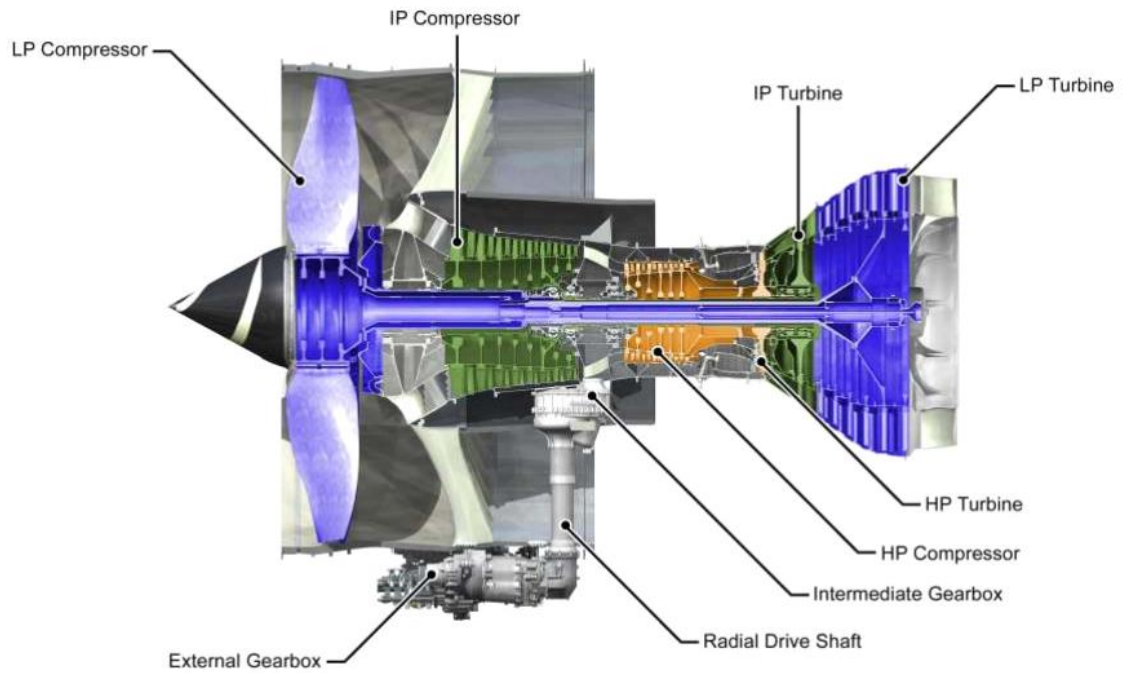
Figure 9: TRENТ 1000, schematic view (source Rolls-Royce).
