INTERIM STATEMENT

Accident occurred to AW609 registration marks N609AG, on 30th October 2015, in Tronzano Vercellese (VC), Italy.

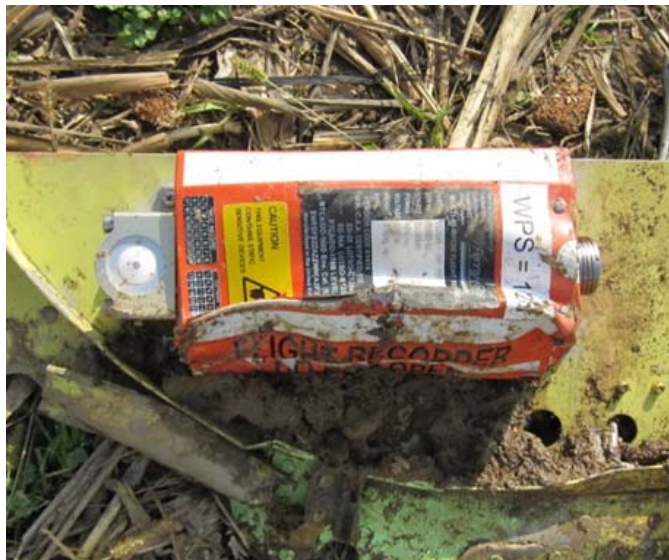
Photo 1: MPFR (combined FDR/CVR) installed on board aircraft AW609 registration marks N609AG.

Meanwhile it was also possible to collect testimonies from witnesses, to find the multi purpose flight recorder (MPFR, a combined CVR/FDR), which was on board the aircraft (photo 1) and to retrieve a copy of the file data package sent via telemetry to the ground station of Leonardo Helicopters (formerly AgustaWestland) in Cascina Costa (VA).

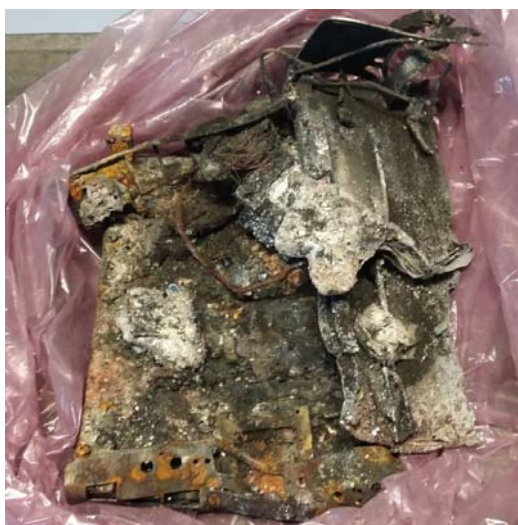
Photo 2: data recorder which received the data from the sensors installed for experimental purpose.

- a data recorder which received all the data from the sensors installed on board for experimental purpose. This recorder collected all the data in an internal memory and some of these data were sent via telemetry to the ground station; this recorder, being a non-protected unit, was destroyed by the crash and the by fire developed after the impact (photo 2);
- a video recorder (DVR), which recorded the data form two cameras: one mounted in the cockpit and the other one mounted on the tail fin; this recorder collected the data in an internal memory device. This recorder, being a non-protected unit, was destroyed by the crash and by the fire developed after the impact (photo 3).

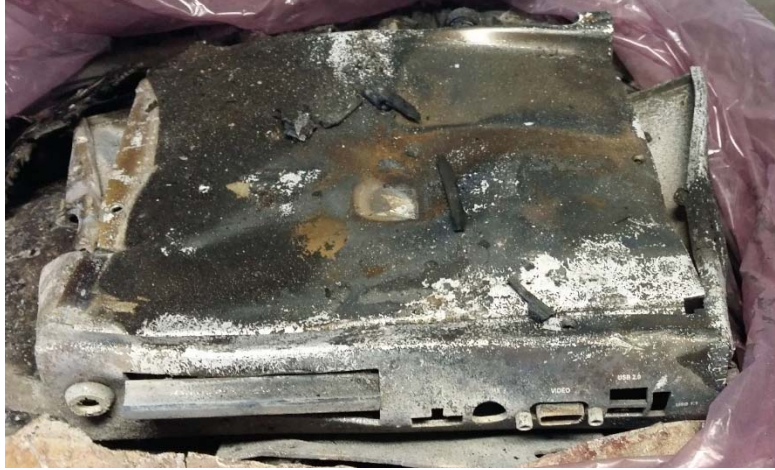
Photo 3: video recorder (DVR) which recorded the data from two cameras.

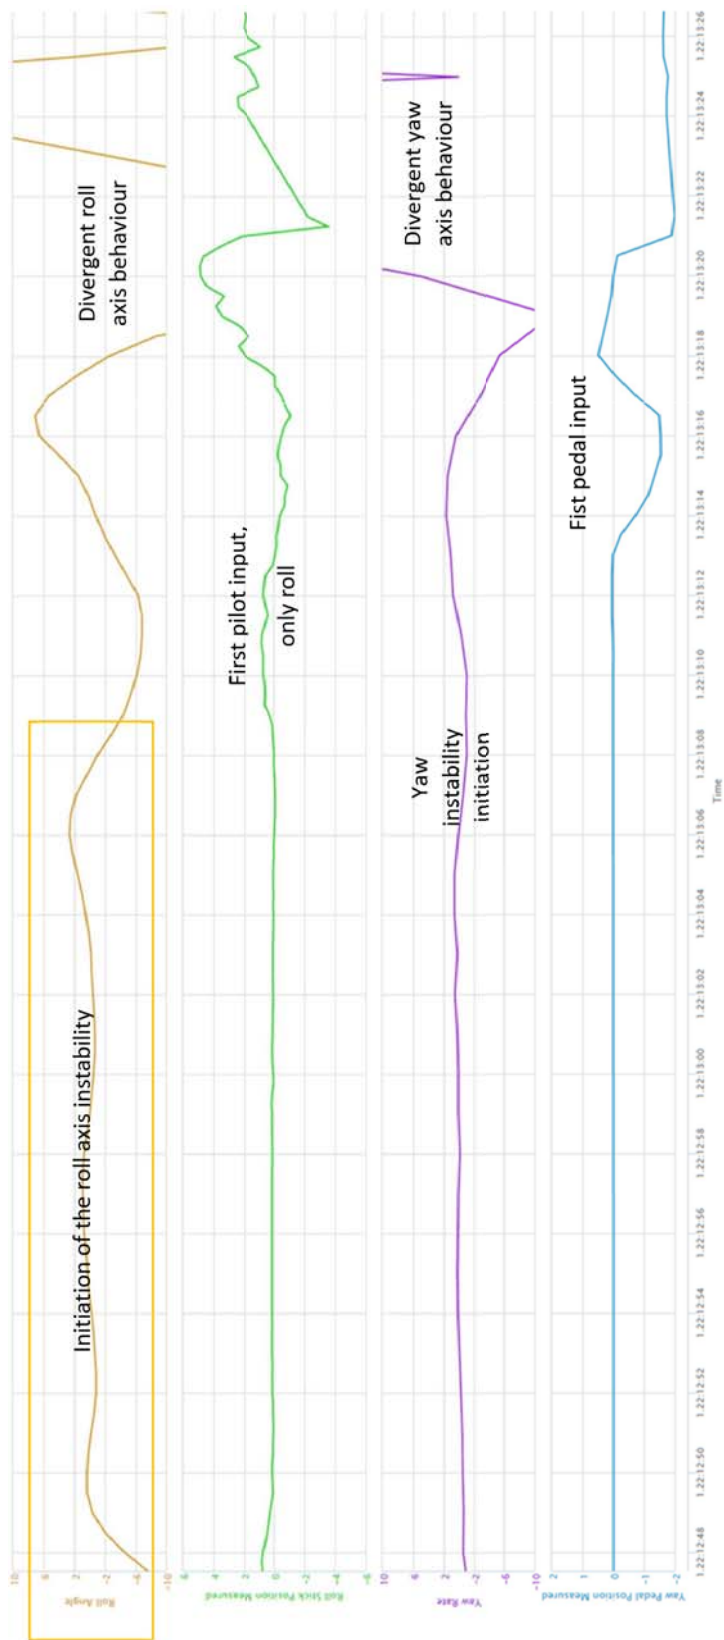
Motivation: in the accident flight, during the execution of high speed test maneuvering in symmetric configuration, the aircraft AW609 encountered lateral-directional oscillation (picture 2, attached "A" to this statement, roll depicted in yellow and yaw rate in purple, data from the MPFR). The safety investigation showed that this phenomenon was present to a lesser degree also in previous flights. It was considered to be slight and not dangerous, being assessed as self-damping.

Motivation: in the accident flight, during the development of the aerodynamic oscillation, the PIC tried to maintain the aircraft control (picture 2, input on the roll depicted in green and input on the yaw in blue, data from MPFR). The oscillation that started on the roll axis was corrected by the PIC acting on the roll control, as normally expected. The AW609 flight control laws however are designed in such a way that input on roll axis is generating also a coupling on the yaw axis.

Picture 2: FDR data - roll axis (yellow), PIC input on roll axis (green), yaw rate (purple), PIC input on yaw axis (blue).

Safety Recommendation: the ANSV recommends, in the framework of the certification process, to verify that the aerodynamic behavior of the aircraft at high-speed conditions will be reviewed, if necessary making use of wind tunnels tests in addition to updated models and simulations that can be representative of the complex flight conditions of this peculiar aircraft.

Recommendation: the ANSV recommends, in the framework of the certification process, to verify that the control laws of the aircraft will be reviewed in the management of the extreme flight conditions in which the aircraft could possibly fly. That verification should be addressed to ensure the effectiveness of the flight controls inputs given by the pilot avoiding the possibility of unexpected and un-commanded coupling effects.
