Our ref. ANSV 1605/17

Subject: serious incident occurred on the 11th of October 2017, at Montichiari Airport (Italy), to BK117D2 registration marks I-BRXA. ANSV safety recommendations.

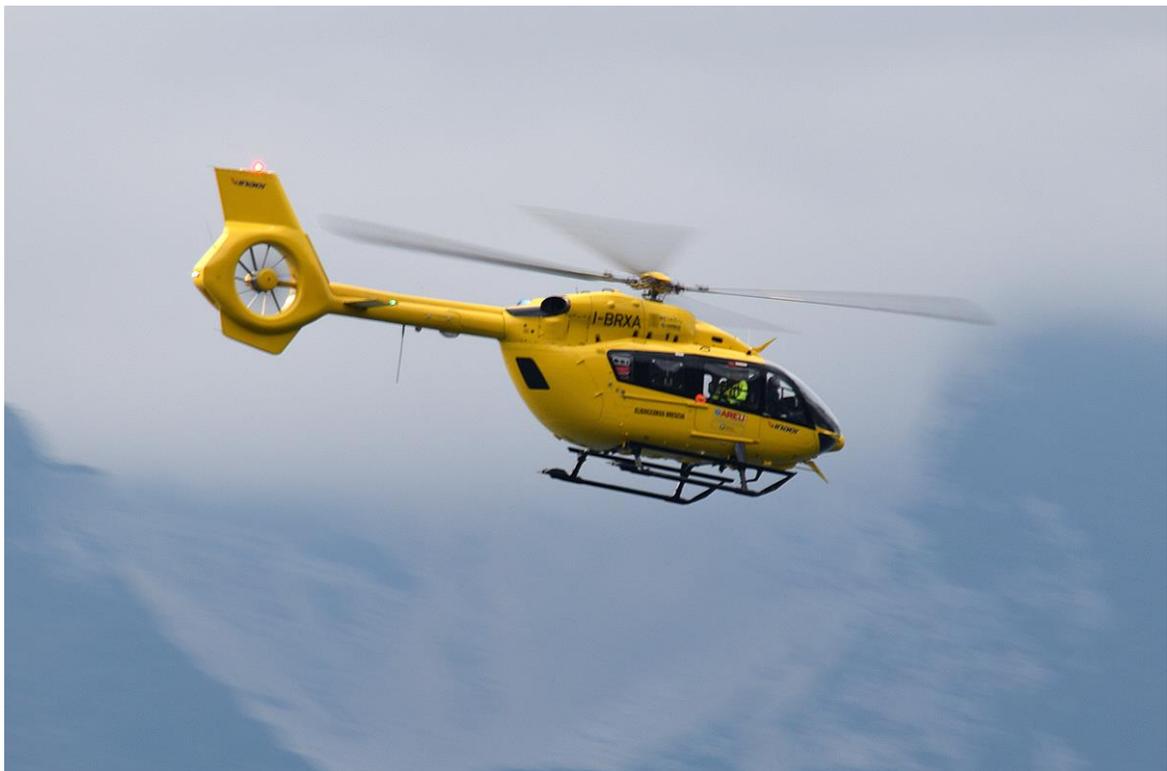
Picture 1: BK117D2 I-BRXA.

On the 11th of October 2017 an HEMS operation departed from a Brescia helipad. On board the BK117D2 registration marks I-BRXA (picture 1) there were six people: pilot, co-pilot, HEMS crew member, Task Expert, doctor, nurse. After 4' 35" being airborne at about 6000 ft, the pilots received the warning light "fire eng02". According to the flight manual procedure the crew established OEI (One Engine Inoperative) condition and the fire extinguishing system was activated. The crew aborted the mission and diverted to the nearest airport, Montichiari (BS). While in descent toward the airport, the "low RPM" indication (referred to the main rotor speed, N_R) and the associated audio message was triggered and displayed. The pilots reported not to be able to control the N_R to turn off the "low RPM" indication. However, they managed to land safely.
