# **PRELIMINARY REPORT**

## **ACCIDENT**

**aircraft Cessna 560 XLS+ registration marks OE-GES,  
Milan Malpensa Airport (Italy),  
5<sup>th</sup> of September 2019**

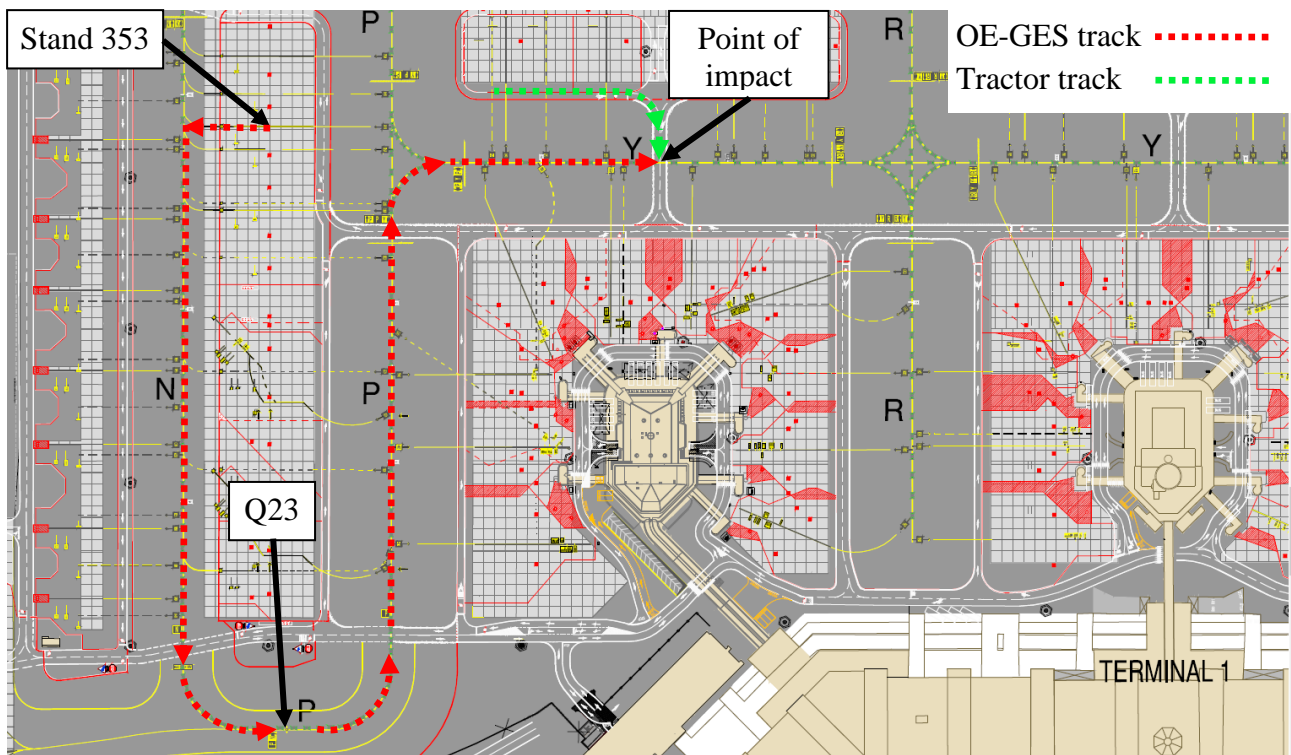
Figure 1: Milan Malpensa Airport, indication of ground tracks.

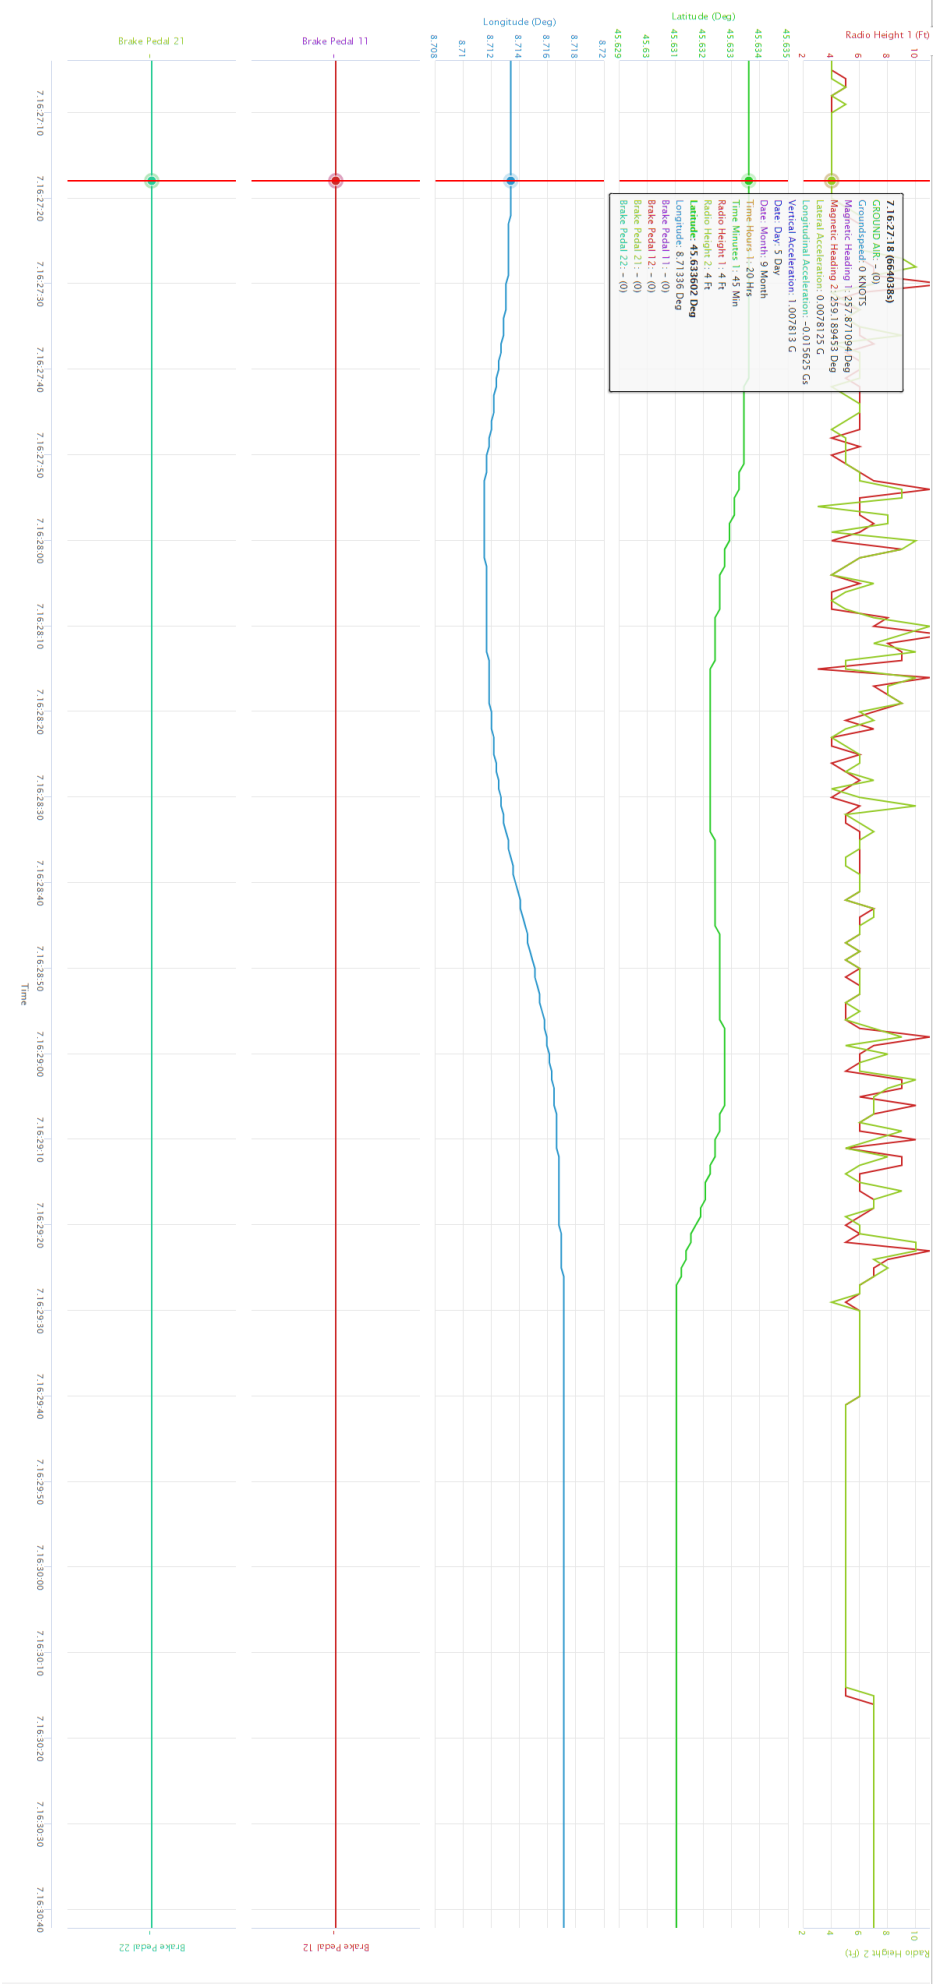
The ANSV Laboratories downloaded the data from OE-GES FDR and CVR<sup>11</sup>. The FDR data were also converted to engineering units and the most significant plots are shown in figures 2 thru 7. For each of the 4 identified accident phases (impact, max lat/long acceleration, rest after impact, stop of all accelerations), the most significant parameters were summarized in table 1. These include time, ground speed, magnetic heading, vertical/longitudinal/lateral acceleration values.

Figure 3: OE-GES FDR data – Start taxiing phase (Radio Height1, Radio Height2, Latitude, Longitude, Brake Pedal 11/12, 21/22).

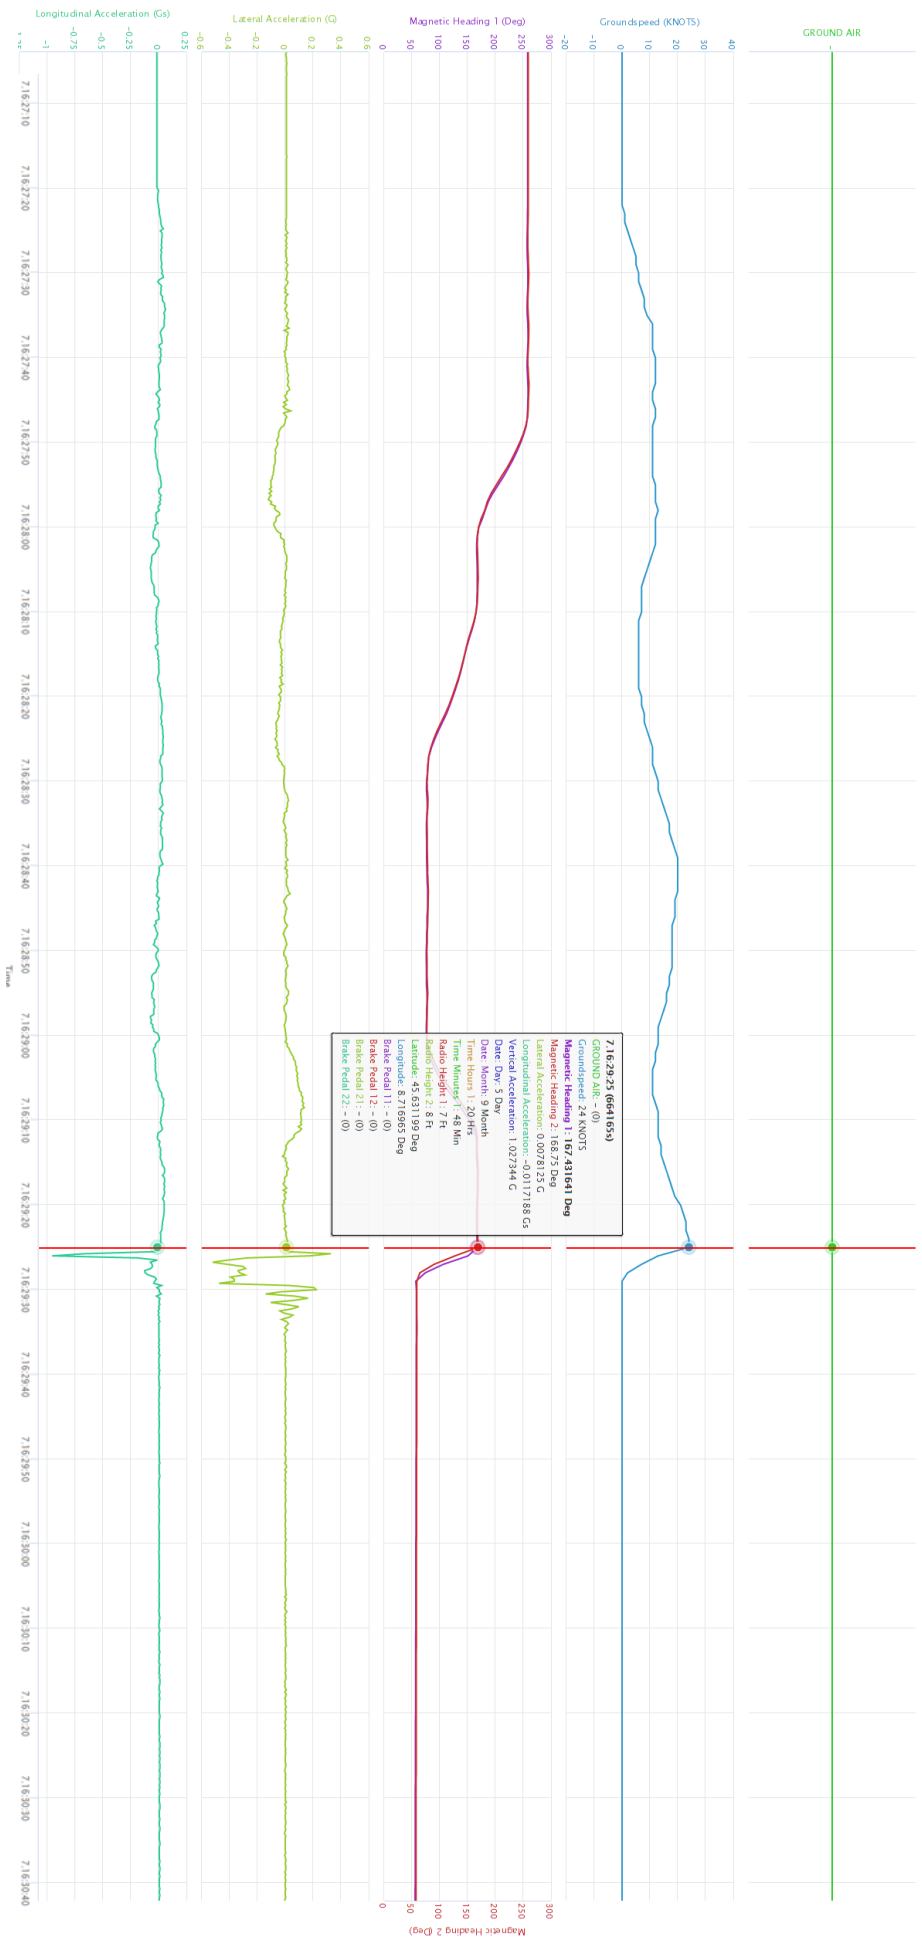
Figure 4: OE-GES FDR data – Impact phase (Ground/Air, Groundspeed, Mag HDG1, Mag HDG2, Lateral Accel, Longitudinal Accel).

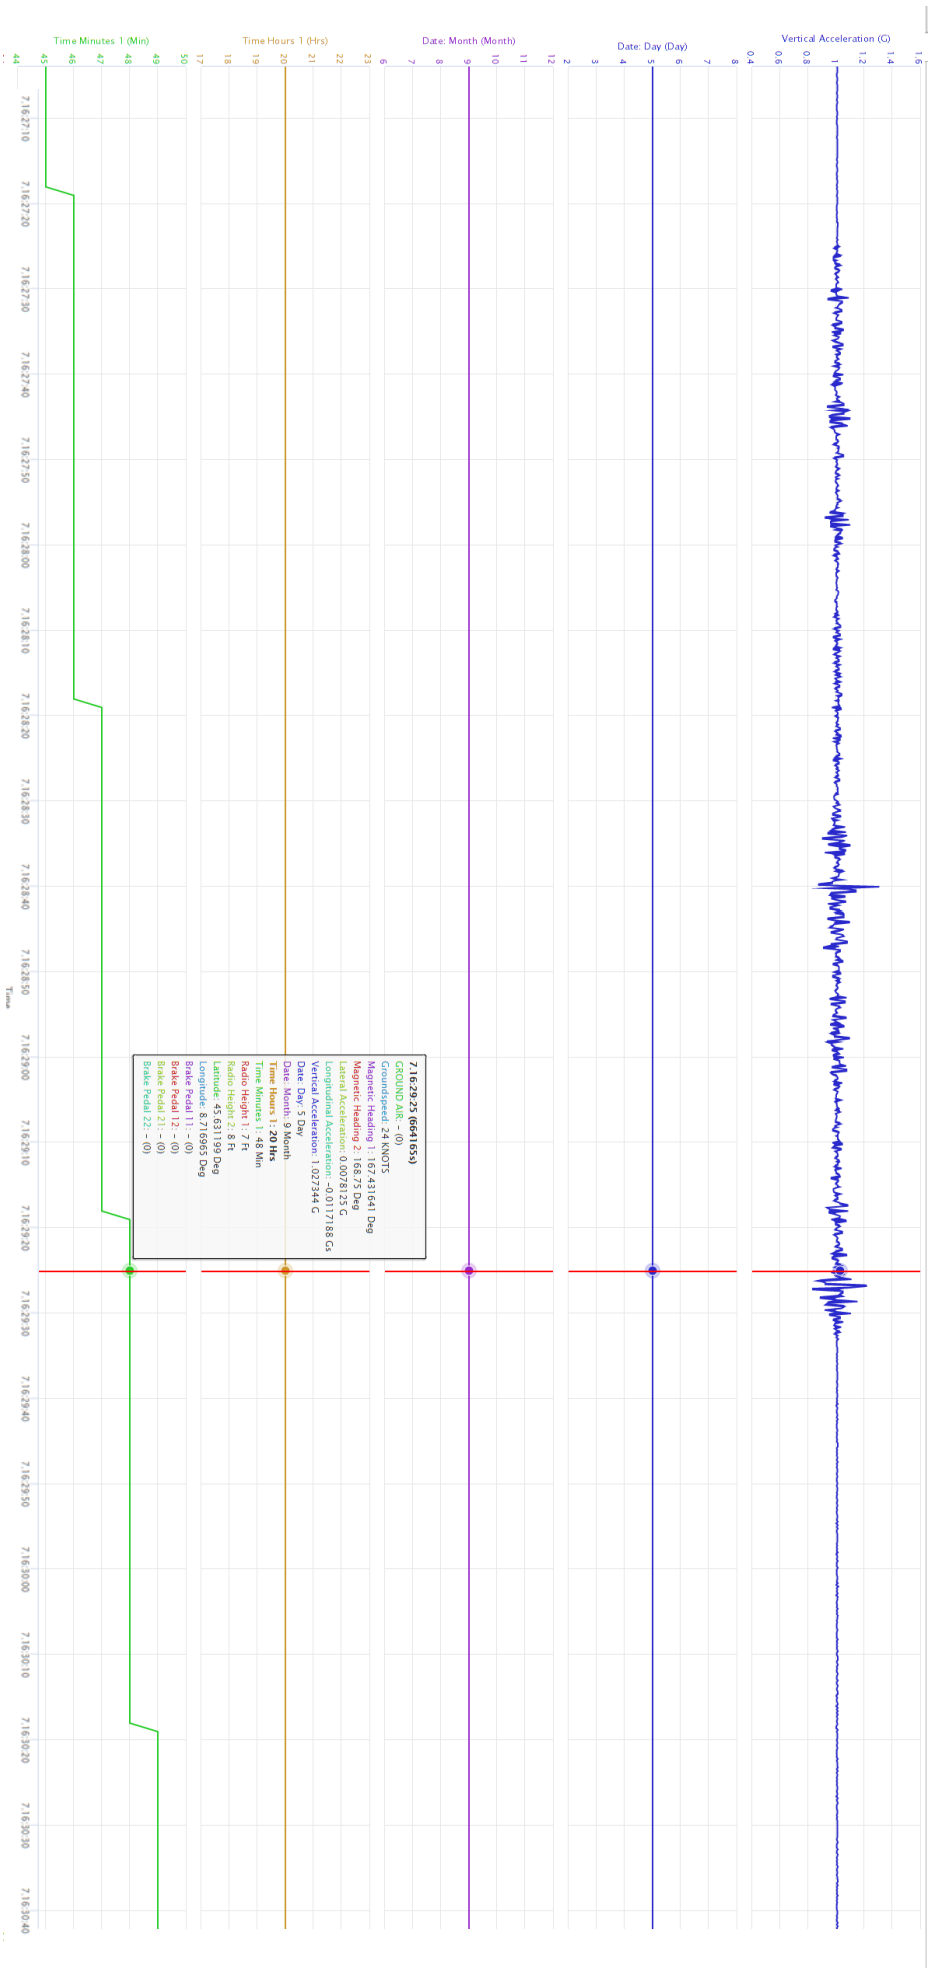
Figure 5: OE-GES FDR data – Impact phase (Vertical Accel, Date, Time).

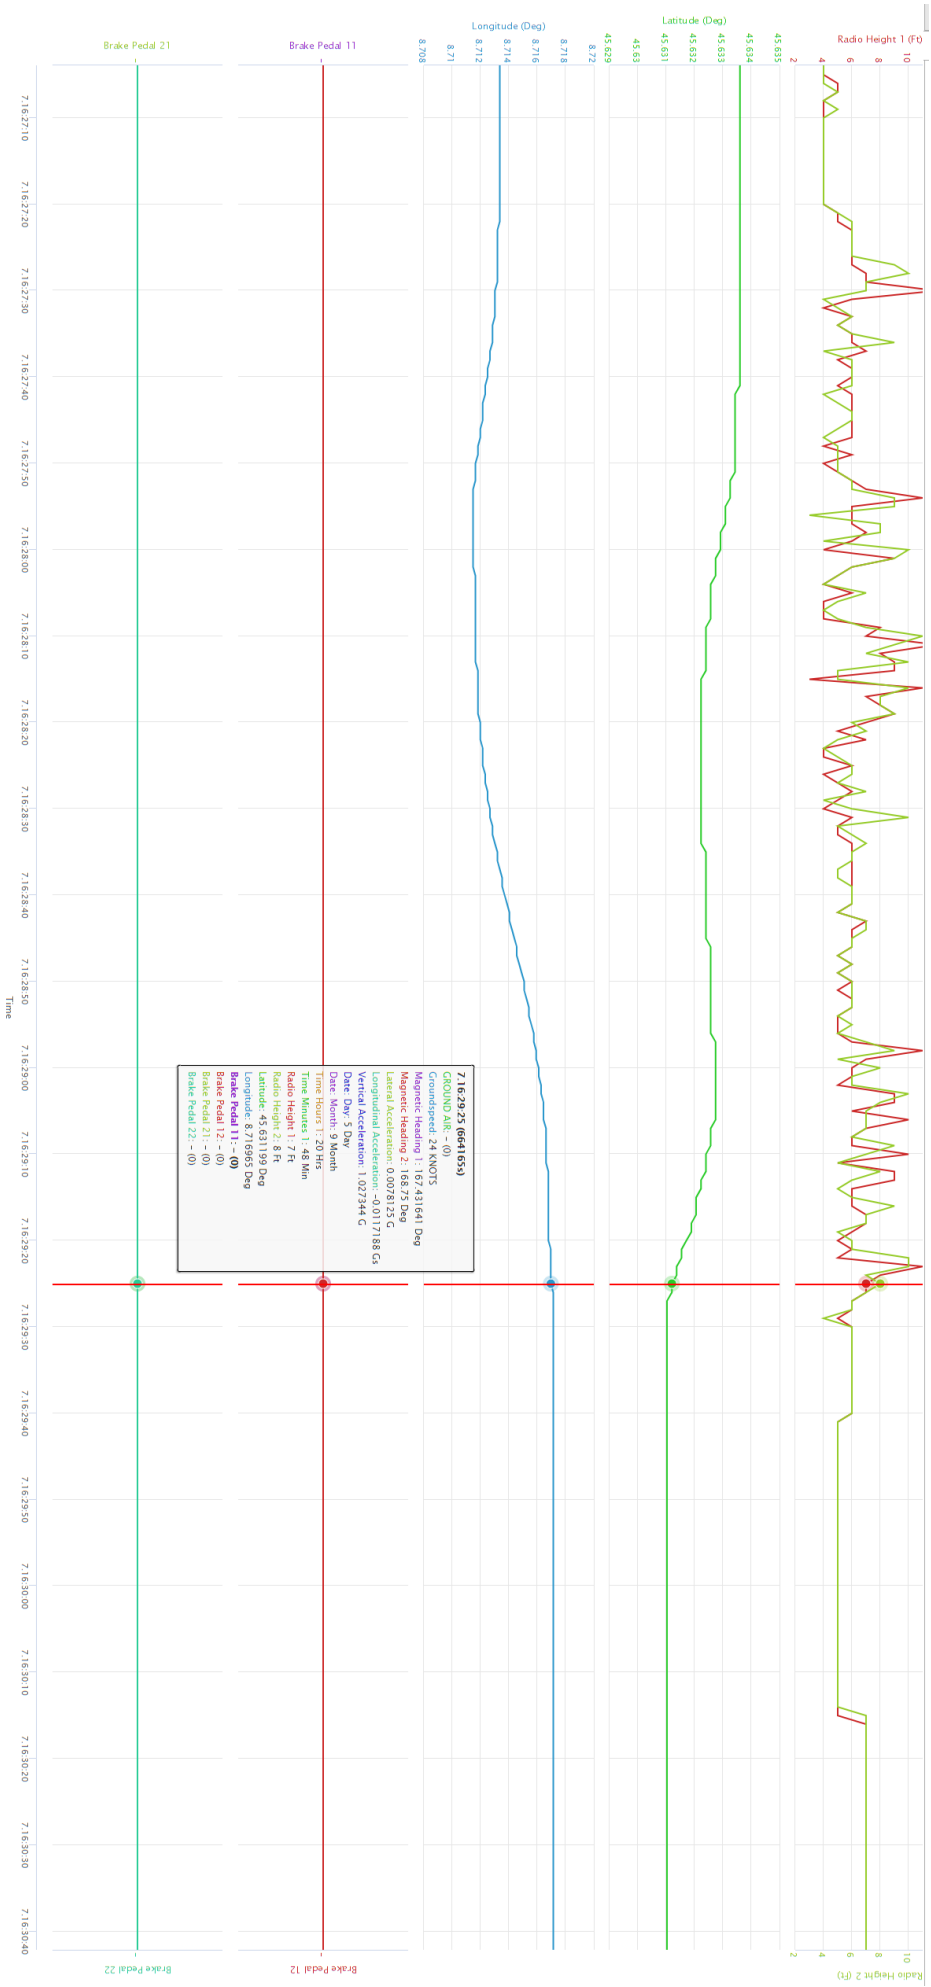
Figure 6: OE-GES FDR data – Impact phase (Radio Height1, Radio Height2, Latitude, Longitude, Brake Pedal 11/12, 21/22).

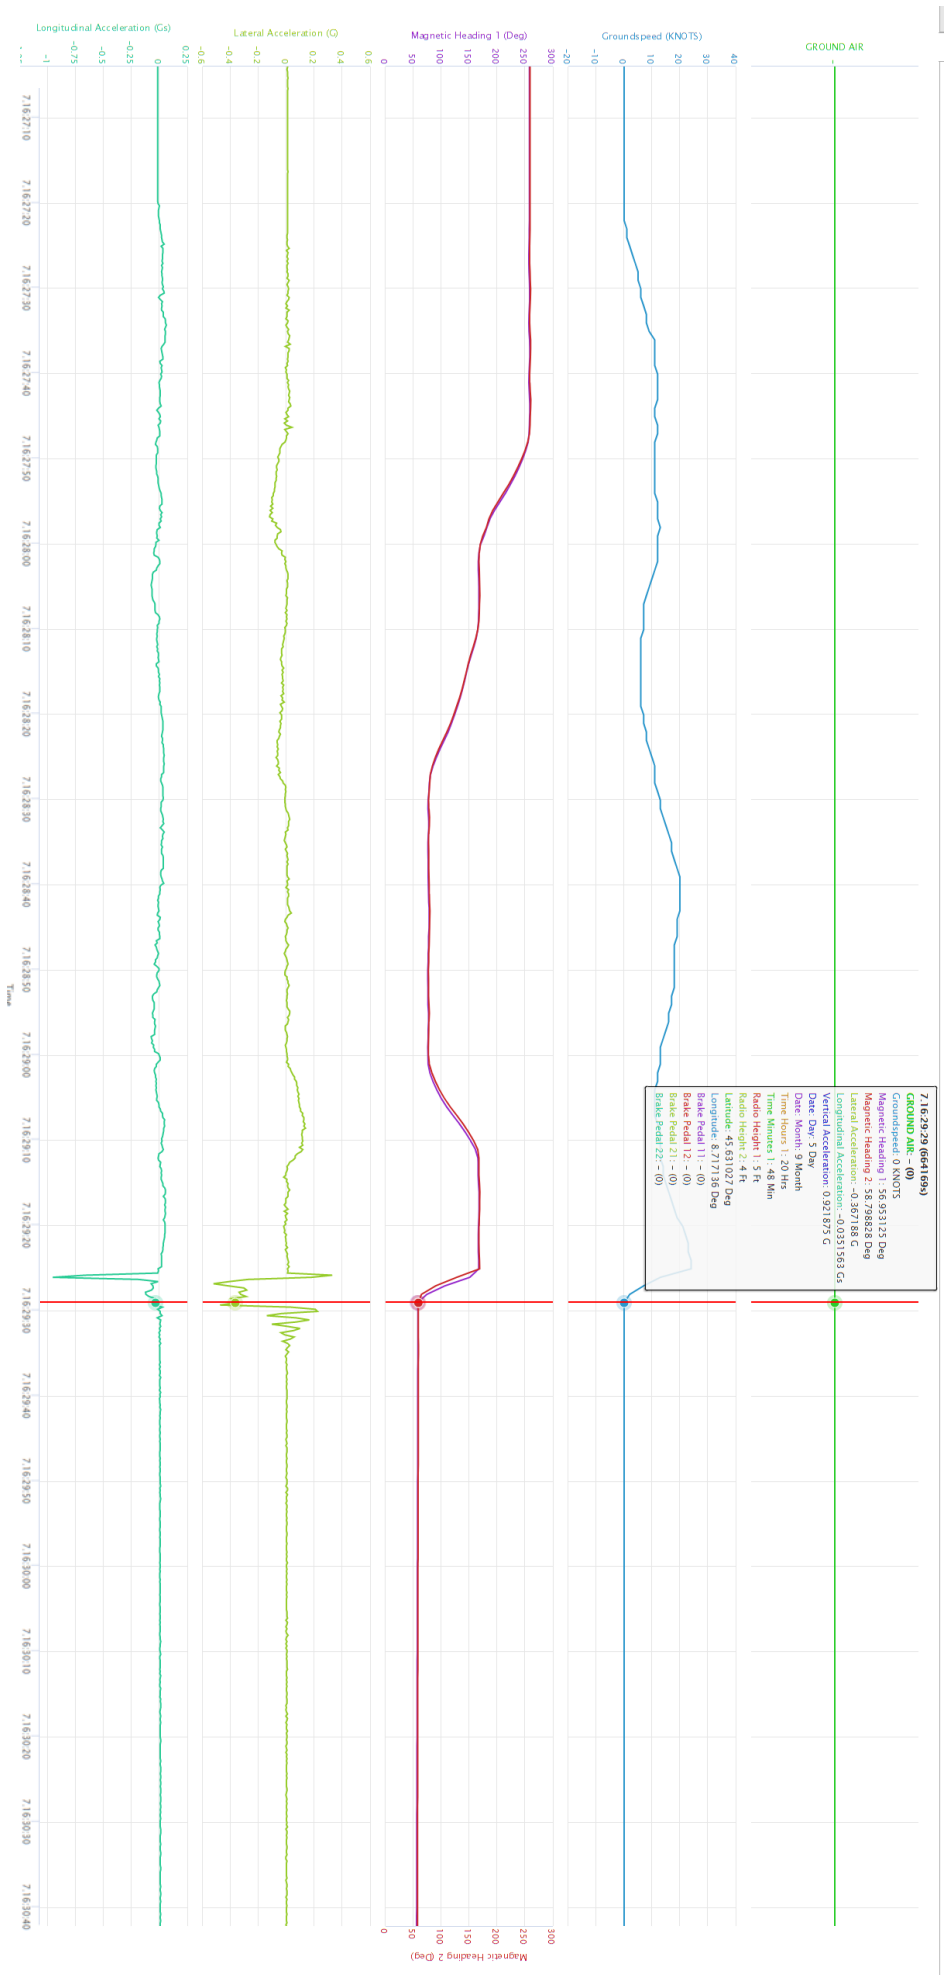
Figure 7: OE-GES FDR data – Rest after impact phase (Ground/Air, Groundspeed, Mag HDG1, Mag HDG2, Lateral Accel, Longitudinal Accel).
